FINAL
*Upper Klamath Lake
Watershed Assessment*

Prepared for
Klamath Watershed Partnership

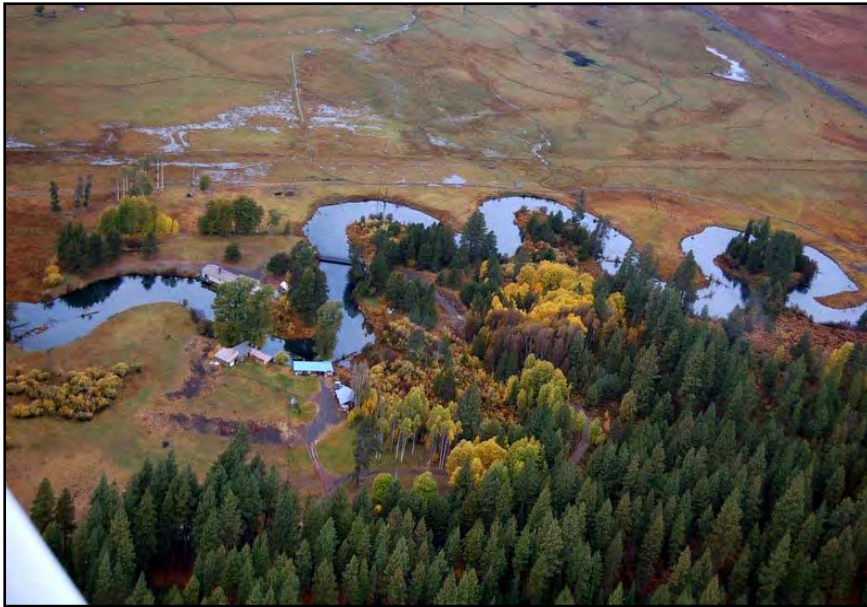
Figure 3-3. Aerial photo of a meandering Rosgen E/F channel in the Wood River Valley (DEA 2009).

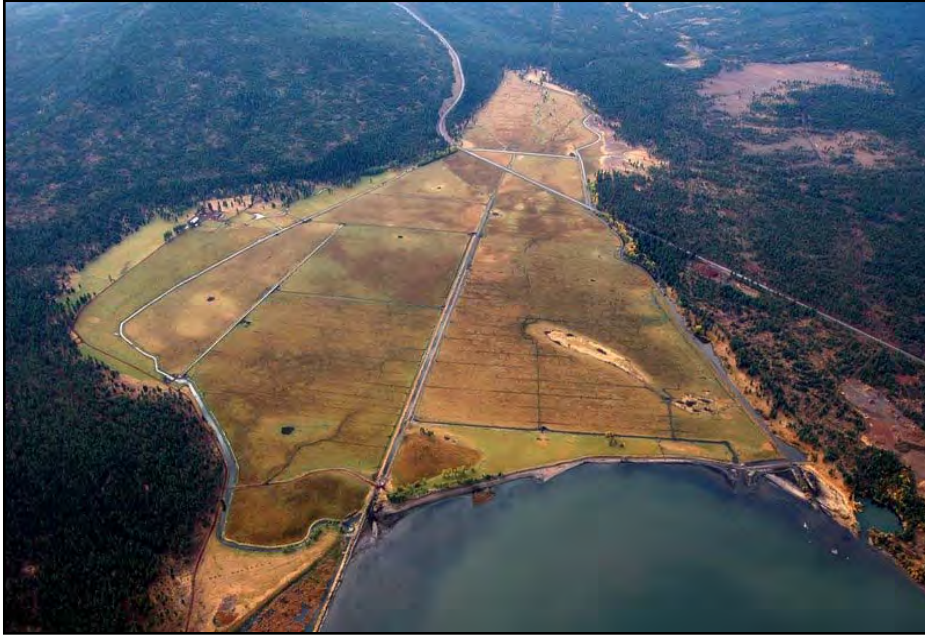
Figure 3-4. Aerial photo of Ditched portion of Denney Creek (DEA 2009).

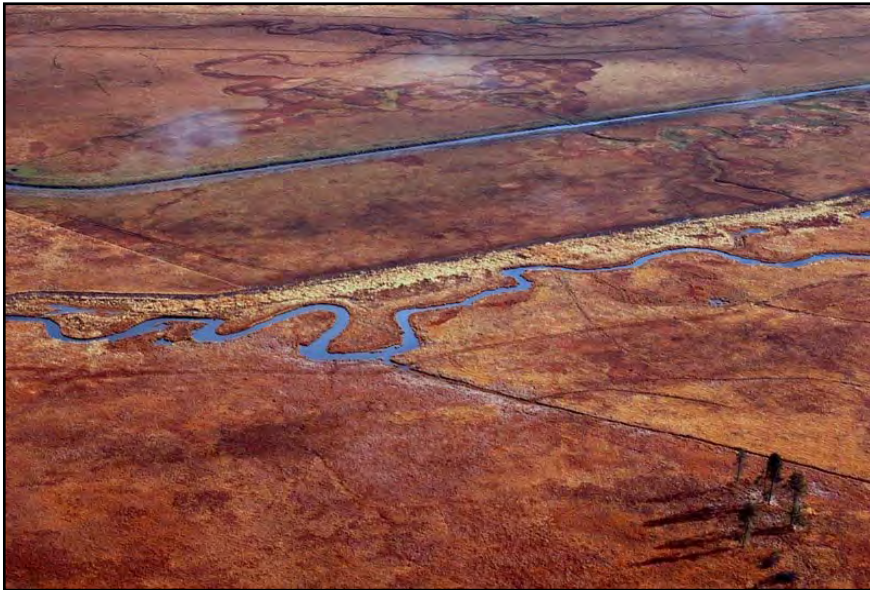
Figure 3-5. Aerial photo of Crane Creek following restoration to re-direct flows from an irrigation ditch to the historic channel (DEA 2009)

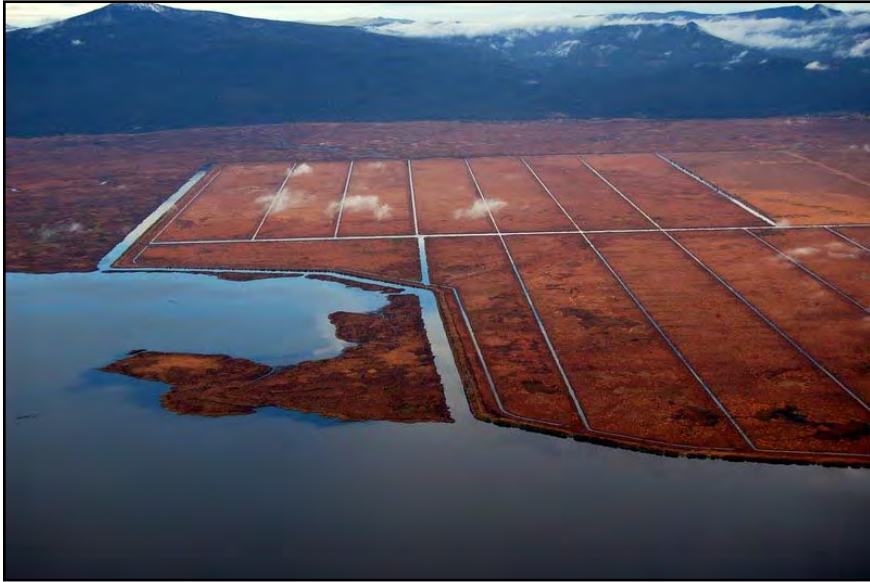
Figure 3-6. Aerial photo of an example of channelization adjacent to Agency Lake (DEA 2009).

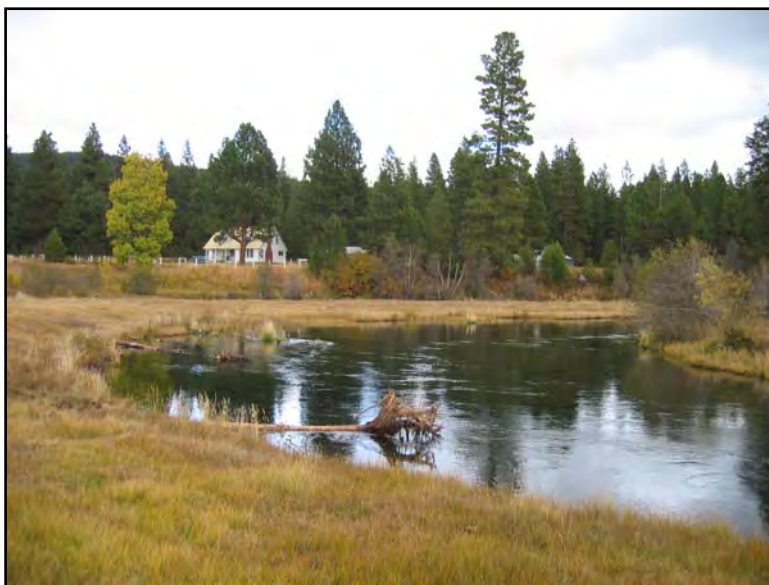
Figure 3-7. Photo of habitat enhancement project along the Wood River (DEA 2009).

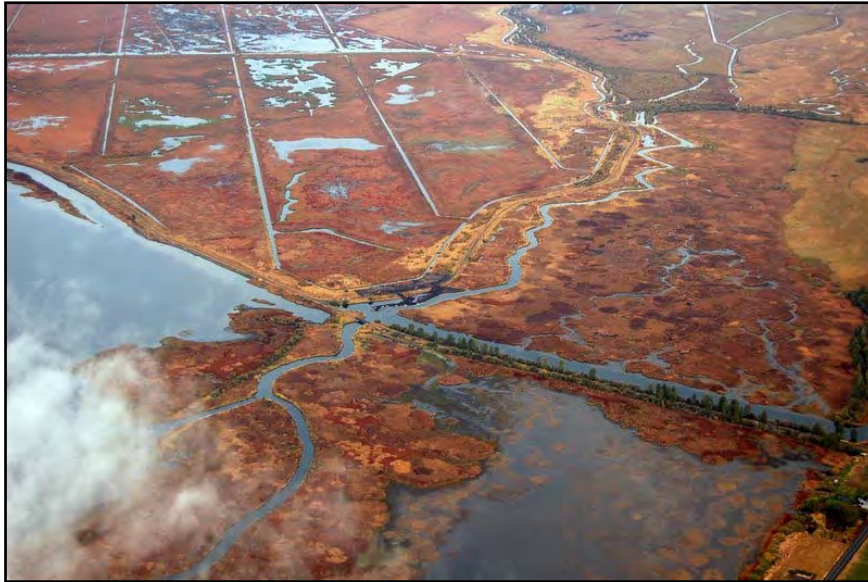
Figure 4-10. Aerial Photo of the Wood River Wetland, the site of many restoration activities (DEA 2009).

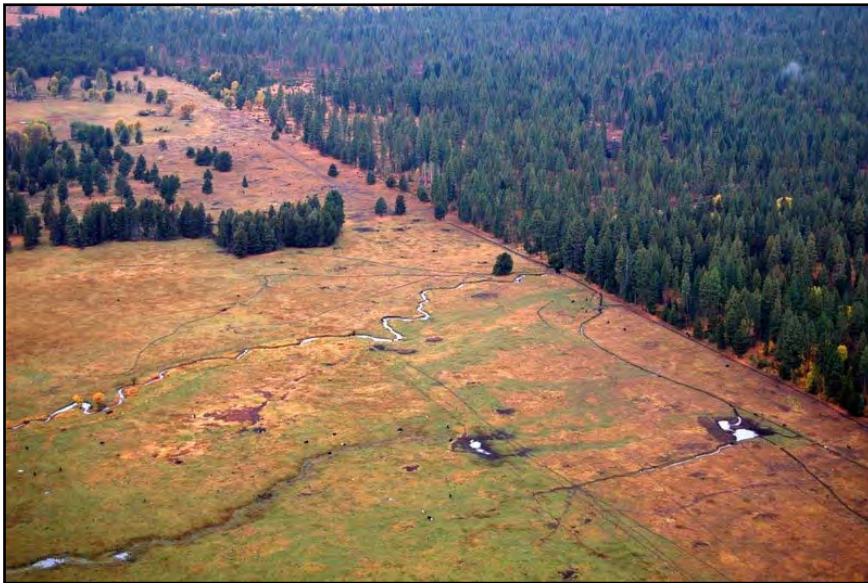
Figure 6-1. Aerial photo of a channel lacking overhead canopy adjacent to forested land (DEA 2009).

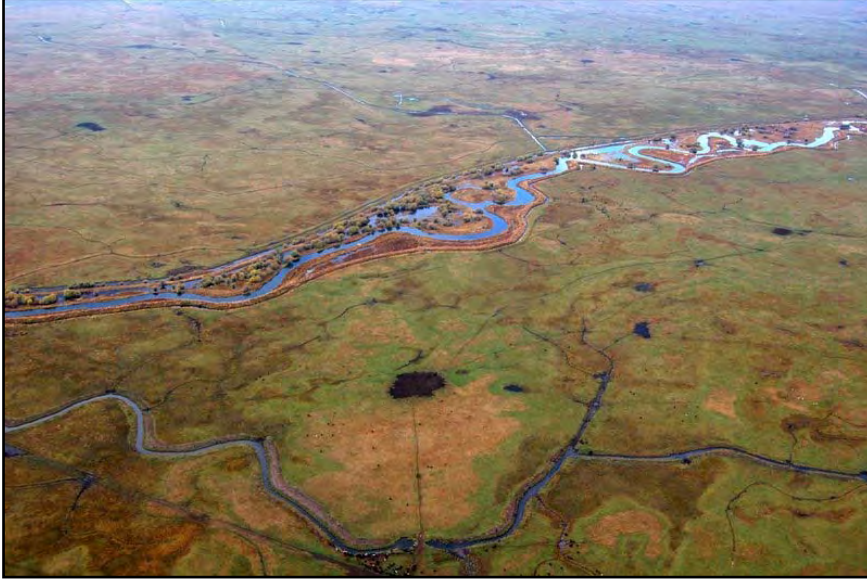
Figure 6-3. Aerial photo of an example of scattered riparian cover along channels located on agricultural lands (DEA 2009).

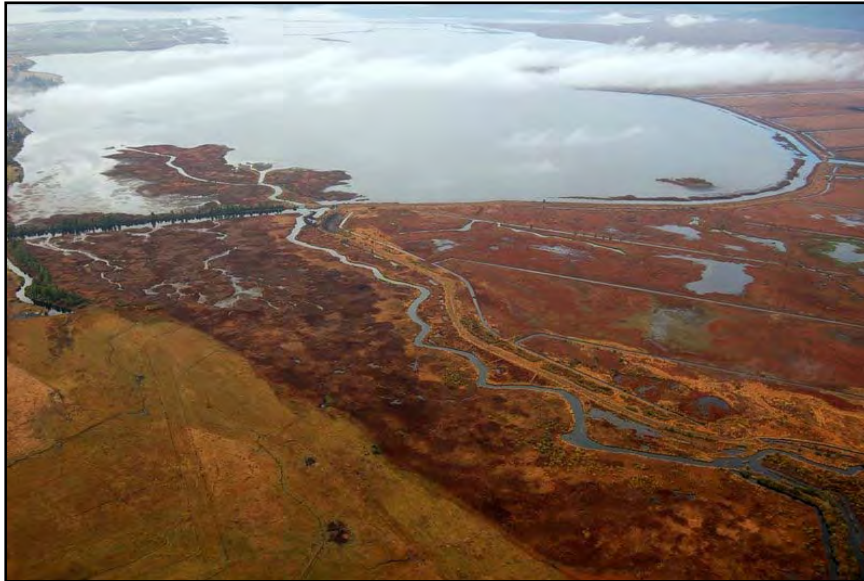
Figure 7-2. Aerial photo of the lower Wood River and Wood River Wetland, adjacent to Agency Lake (DEA 2009).

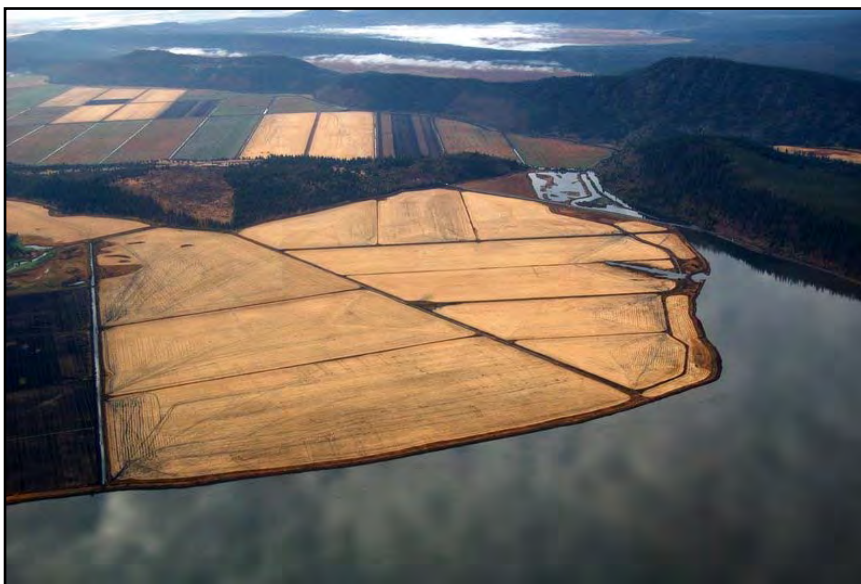
Figure 7-3. Aerial photo of Caledonia Marsh, adjacent to Upper Klamath Lake (DEA 2009).

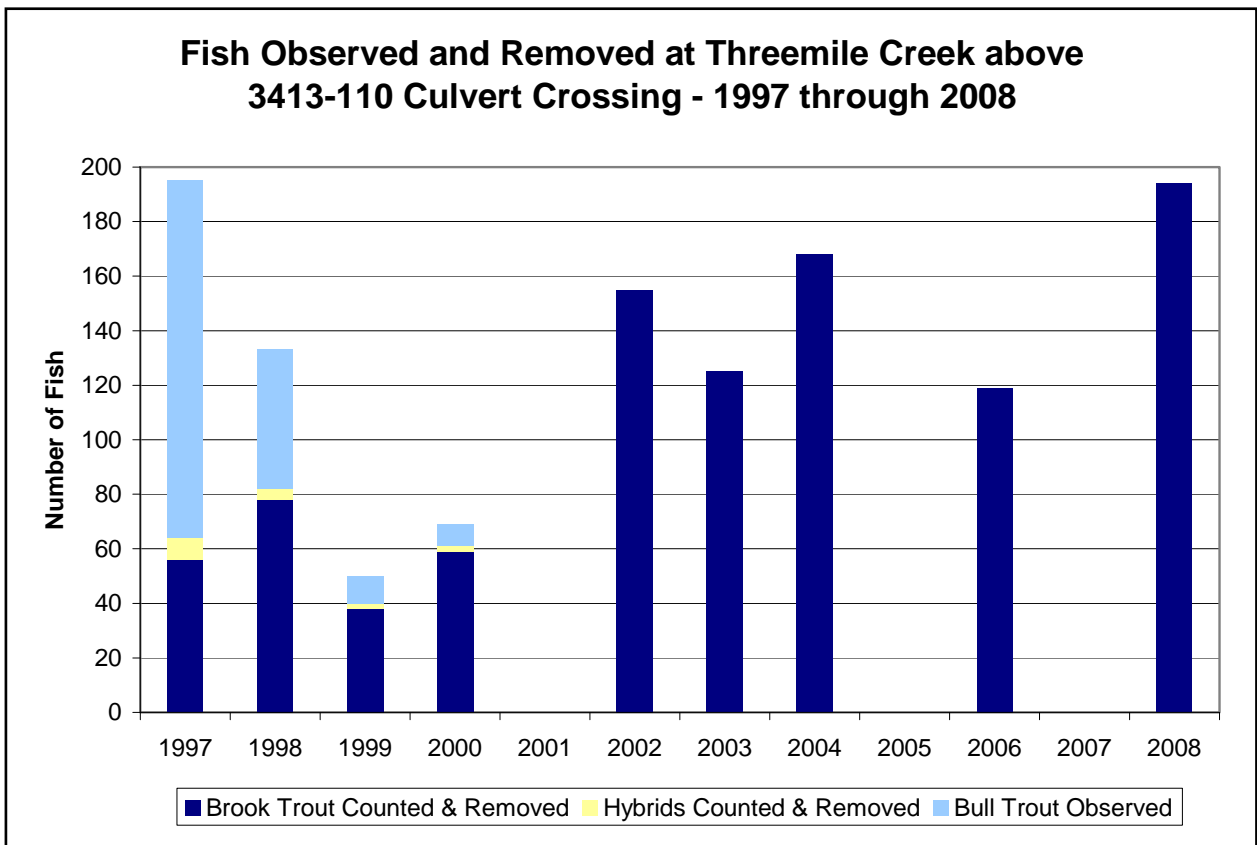
Figure 9-1. Fish observed and removed at Threemile Creek above 3413-110 culvert crossing, 1997 through 2008 (USFS 2009).

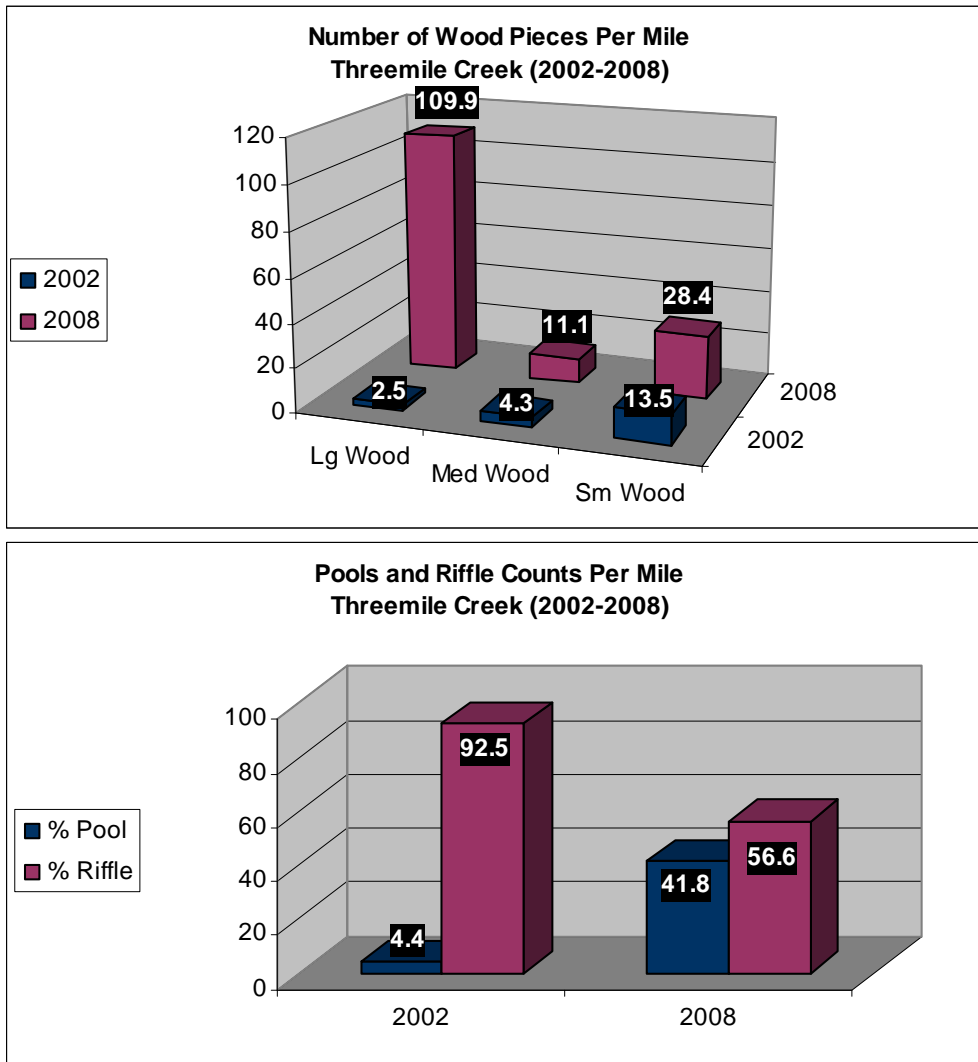
Figure 9-6. Threemile Creek wood pieces per mile and pool/riffle counts per mile pre- and post-restoration (USFS 2009).

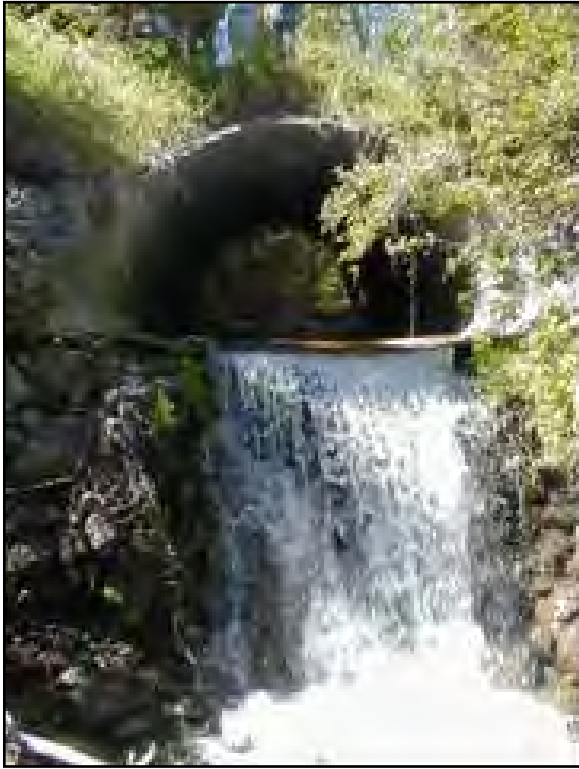
Figure 9-7. Photo of Impassable Fish Barrier at Forest Road 3413-110 (USFS 2007)
