SYCAN RIVER ASSESSMENT AND RESTORATION FEASIBILITY STUDY

August 30, 2007

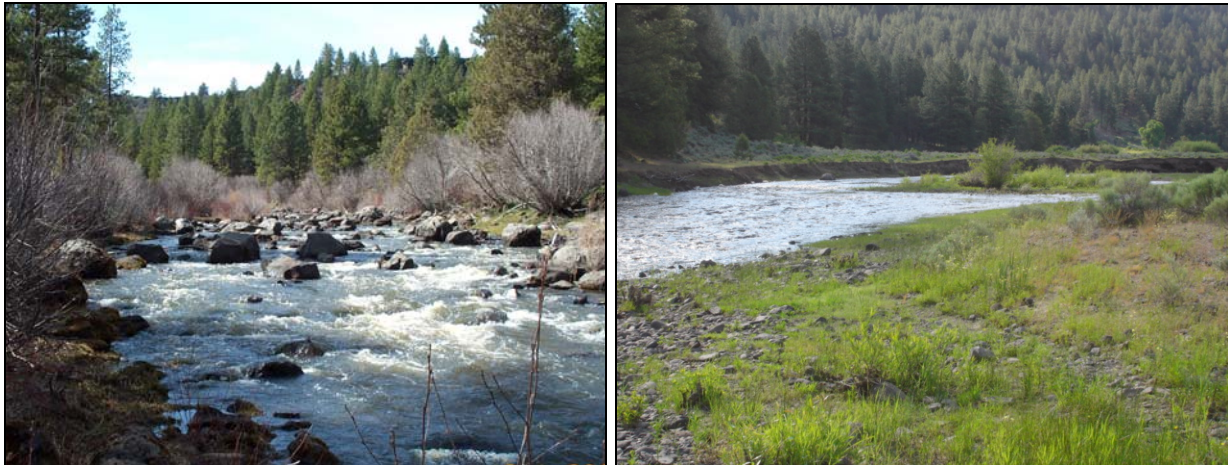
Figure 2-1. River corridor conditions in Reach 1 – Canyon Reach Transition are characterized by a low sinuosity, moderate gradient channel in the Coyote Bucket Canyon (left) to moderate sinuosity, broader river corridor through the river corridor transition (right).

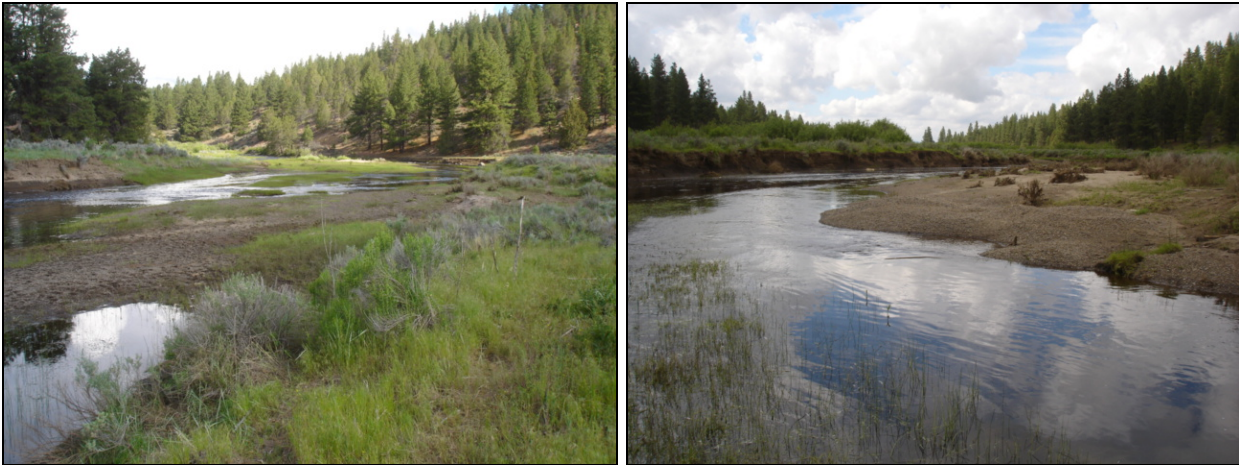
Figure 2-2. Reach 2 is characterized by a more sinuous channel and expanding beltwidth. Sediment is stored in point bars and lateral bars that are colonized with sediment-trapping riparian vegetation.

Reach 2 extends from Station 22+00 to Station 76+00. The Sycan River in Reach 2 is characterized by increasing channel sinuosity, alternating pool-riffle morphology, and frequent point bars and lateral bars where sediment is stored (Figure 2-2). Channel and floodplain development is occurring between the lateral terraces. Eroding streambanks vary in the slope of the bank face. In areas where streambanks are actively eroding, large mats of vegetation and soil cleave from the bank and fall into the river. Where the eroding banks have reached an angle of repose or the bank is protected from stream energy, sedges buffer the eroding bank from the river.

Figure 2-2. Reach 2 is characterized by a more sinuous channel and expanding beltwidth. Sediment is stored in point bars and lateral bars that are colonized with sediment-trapping riparian vegetation.

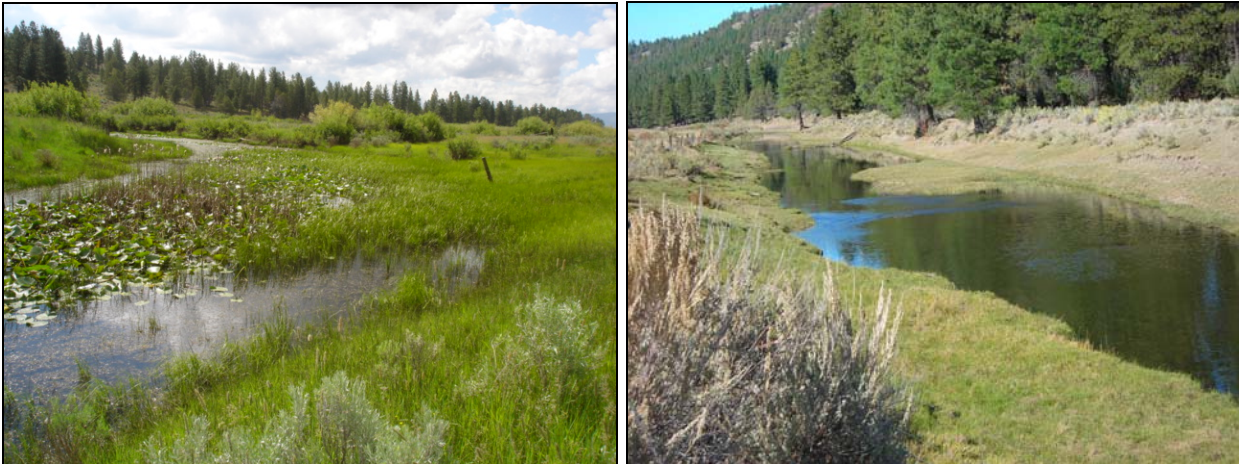
Figure 2-3. Relict channels on the floodplain in the vicinity of Station 95+00 convey water during flood events and retain water through most of the year (left). Downstream of the floodplain area, the Sycan River is confined by the eastern hill slope (right).

Reach 3 extends from Station 76+00 to Station 137+00. The Sycan River valley bottom narrows again in Reach 3. The river corridor necks down with the encroachment of the eastern hillslope on the river channel. The through Reach 4, channel sinuosity decreases and the channel is confined between lateral terraces. Floodplain areas are limited through the reach except between Station 90+00 and Station 102+00 where relict channel scrolls convey flow during flood events and retain spring water throughout the year (Figure 2-3). Downstream of this floodplain section, the river follows the valley's fall line and is confined between the eastern hillslope and a western high terrace. Springs and seeps arise from the western terrace and drain to the river. Developed ponds on the western terrace contribute to the subsurface discharge.

Figure 2-3. Relict channels on the floodplain in the vicinity of Station 95+00 convey water during flood events and retain water through most of the year (left). Downstream of the floodplain area, the Sycan River is confined by the eastern hill slope (right).

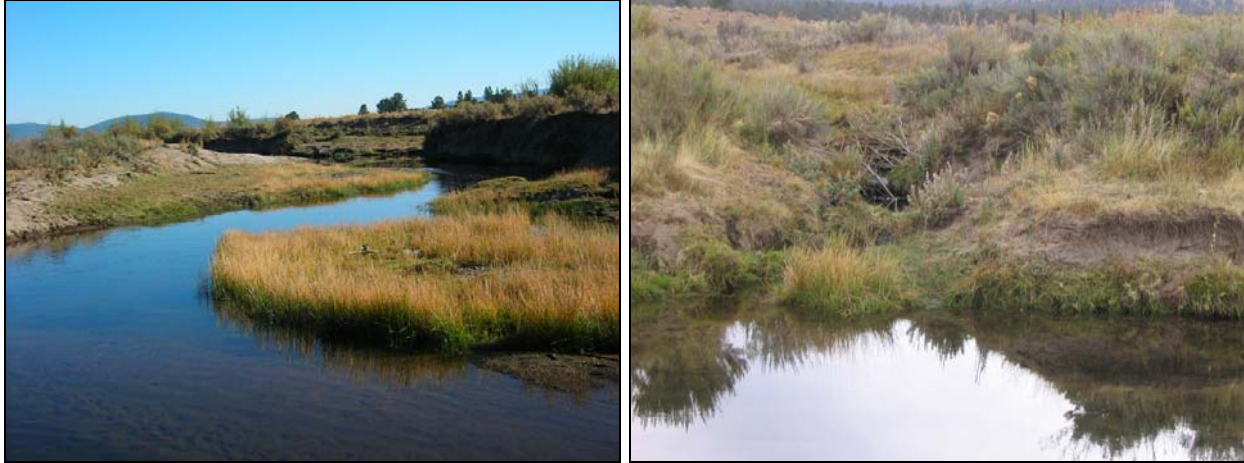
Figure 2-4. Sedges/rushes colonize point bars and confine the baseflow channel inside of the larger active channel bracketed by lateral terraces (left). A beaver dam controls the flow from an off-channel wetland to the Sycan River near Station 152+00 (right).

Reach 4 extends from Station 137+00 to Station 172+00. Reach 4 is characterized by a meandering planform downstream from the confined channel conditions in Reach 3 (Figure 2-4). The channel in Reach 4 is dynamic, including active lateral migration, bank erosion, and an active

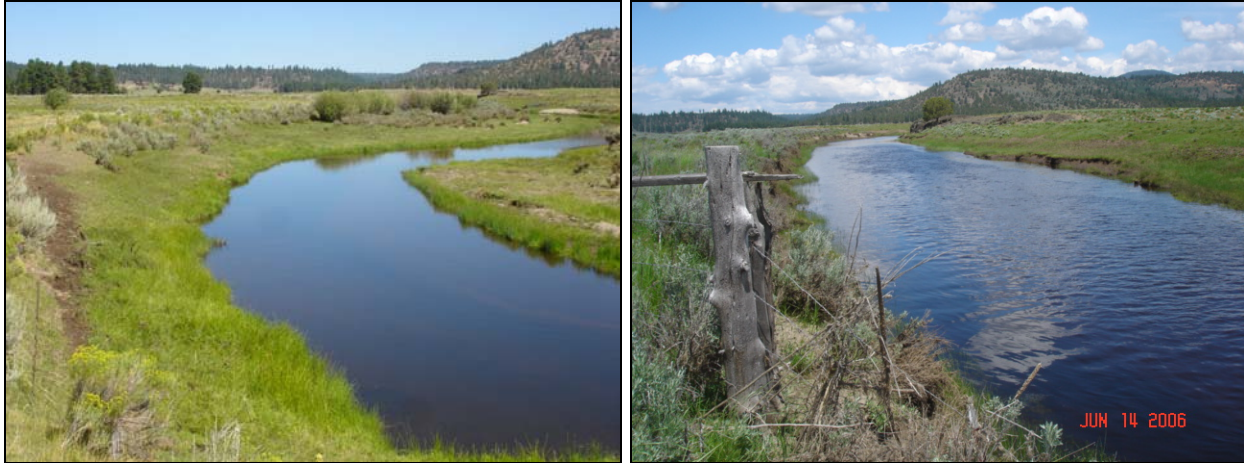
Figure 2-5. River corridor conditions in Reach 5. The channel is confined between lateral terraces. Vegetated surfaces are emergent at base flows (left) are submerged during runoff (right).

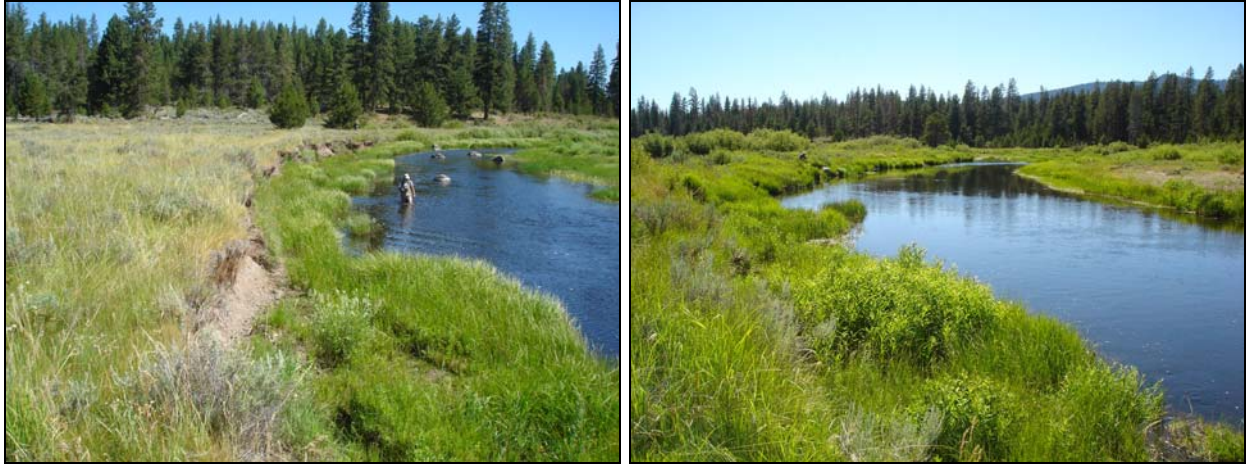
Figure 2-6. Examples of the riparian vegetation communities in the Teddy Powers Meadow reach of the Sycan River. A sedge/rush fringe now buffers the eroding banks from the river (left). Multiple age classes of willows and other riparian vegetation have narrowed the channel and stabilized sediment.

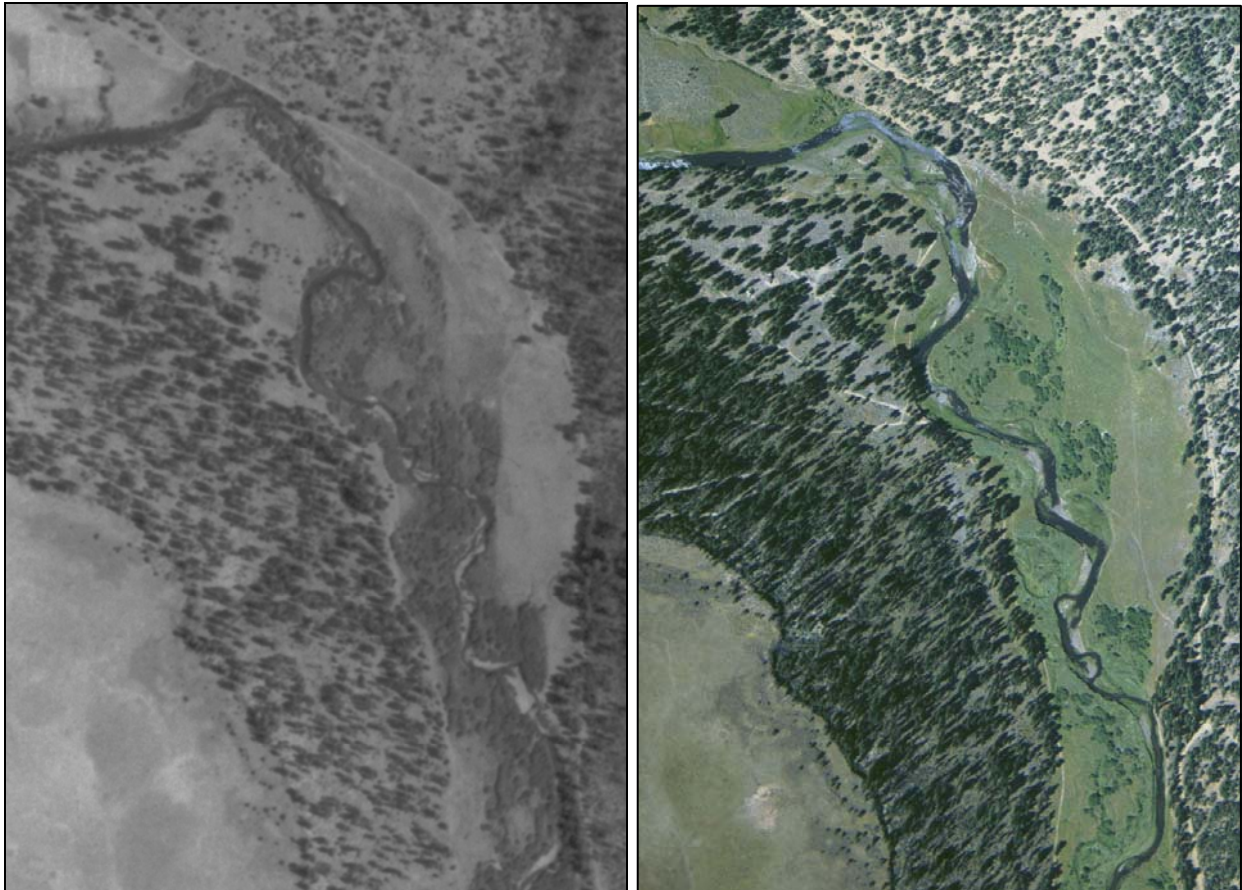
Figure 3-1. A comparison of the Sycan River in Reach 1 and Reach 2 in 1941 (left) and 1998 (right). The riparian community has become less dense and the river straighter over time.

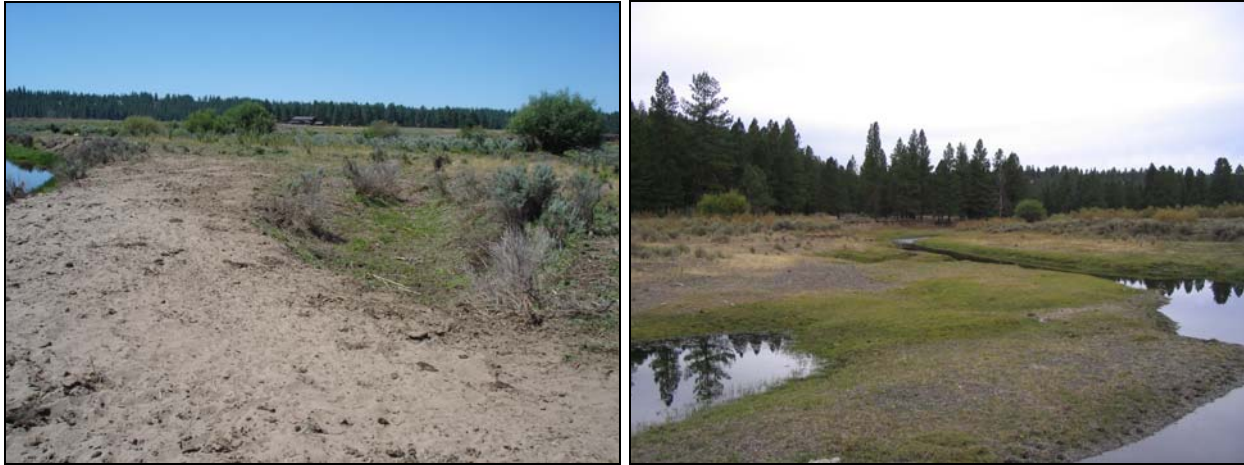
Figure 3-3. Examples of grazing impacts on the Sycan River floodplain in the project area. Repeated trampling of floodplain areas (left) and grazing vegetation within the active channel corridor have led to channel instability.

Livestock effects on the river corridor includes vegetation removal, land surface compaction, and streambank trampling. Vegetation removal is most prominent on land surfaces paralleling the low flow channel. Although these areas are submerged during high flows, sedges, rushes, and willows colonize these sites. These species provide high quality forage proximate to a water source. Grazing of this vegetation is believed to have modified the Sycan River's resistance to bank erosion and contributed to channel instability. Near-bank vegetation that would increase sediment retention and promote streambank building has been lost from much of the upper project area. Grazing on floodplain and terraces has lead to soil compaction. Compacted surfaces decrease surface permeability and promote surface water routing. Disturbed surfaces are also more susceptible to noxious weed invasion. Cattle trampling of streambanks increases bank instability and erosion (Figure 3-3). Repeated trampling related to travel routes breakdown banks and decrease vegetation diversity.

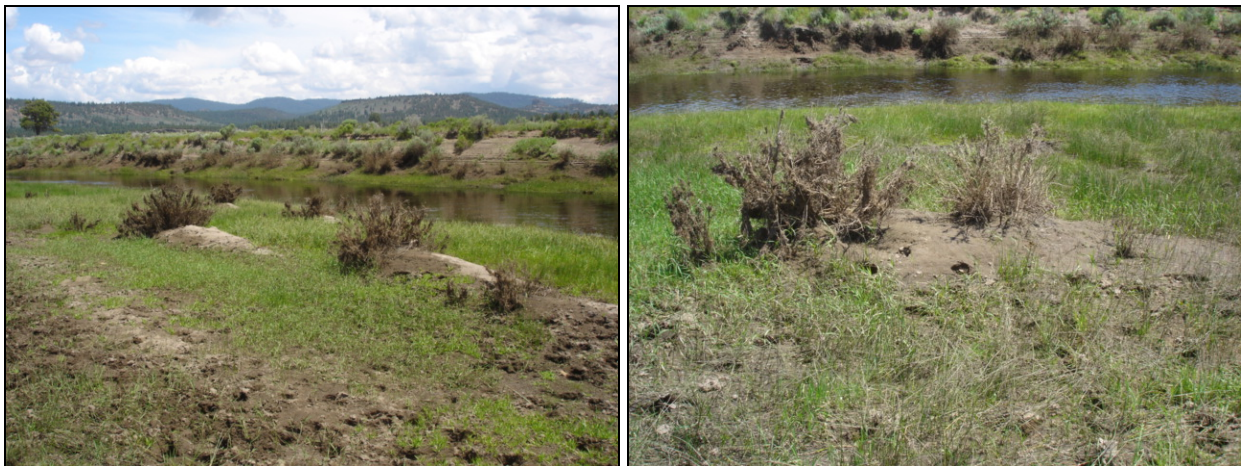
Figure 3-4. Two examples of the influence of riparian vegetation on sediment trapping on the Sycan River illustrate the role of floodplain vegetation in storing fine sediment. Silver sagebrush on the floodplain creates turbulence and sediment deposition. If left undisturbed over time, these sites would be colonized by vegetation and bank building would take place.

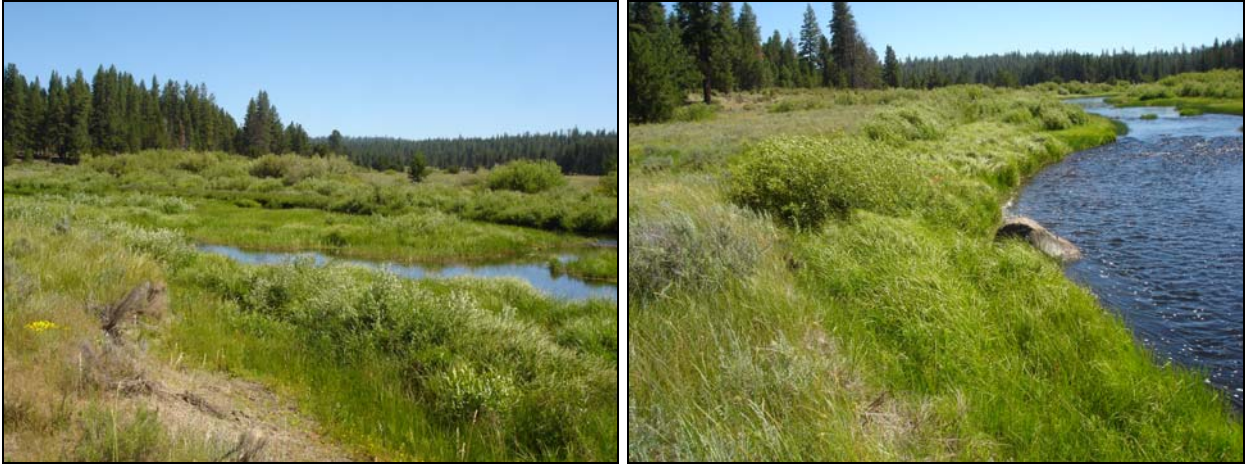
Figure 3-5. Riparian vegetation in the Teddy Powers Meadows reference reach is characterized by sedges/rushes at the channel edge grading to willows at the edge of the active flood channel. Sage brush and other drier upland species occupy the low terrace.

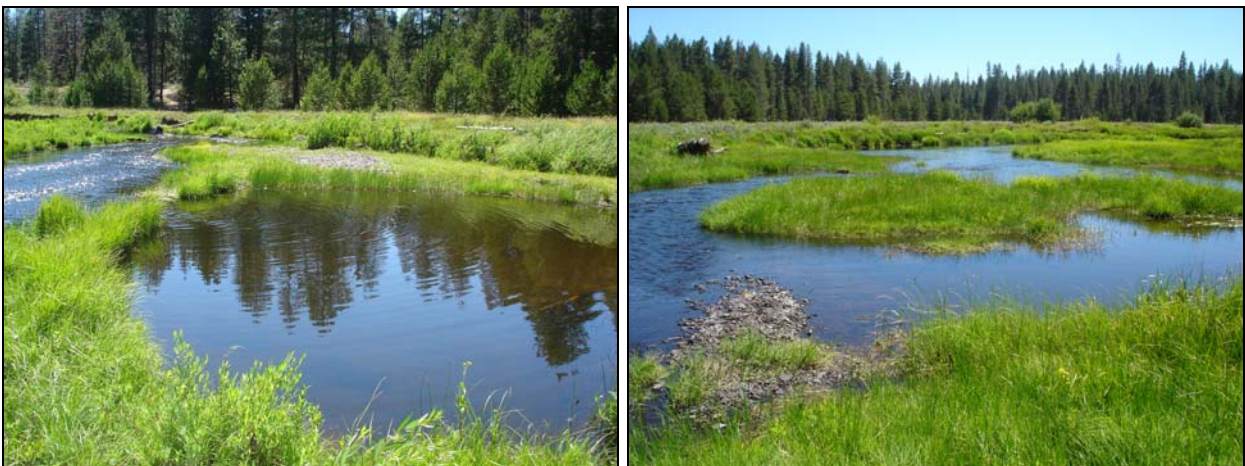
Figure 3-6. River corridor habitats including a floodplain pond (left) and side channels contribute to aquatic habitat diversity in the reference reach. Several features appear to have been influenced by beavers.

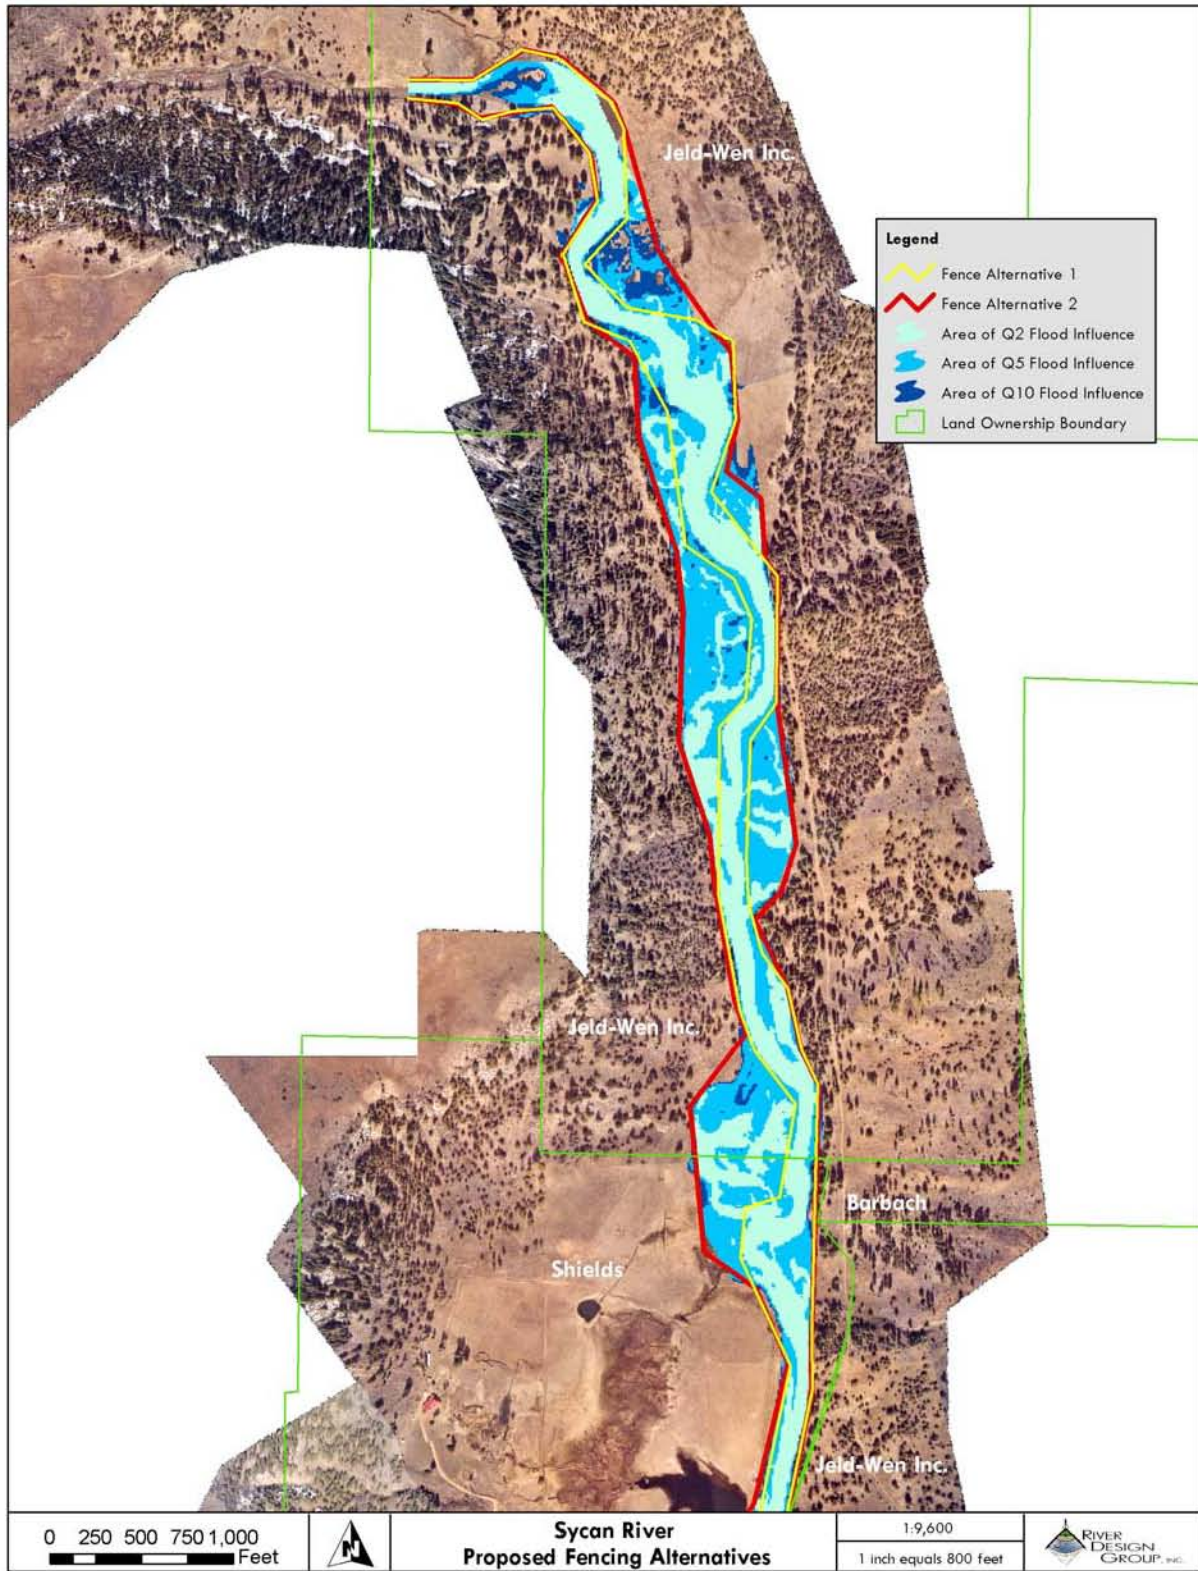
Figure 4-1. The proposed fencing alternatives map for Reach 1 through the middle of Reach 3. The flood extents, Alt. 1 and Alt. 2 fence locations, and landownership boundaries are presented.

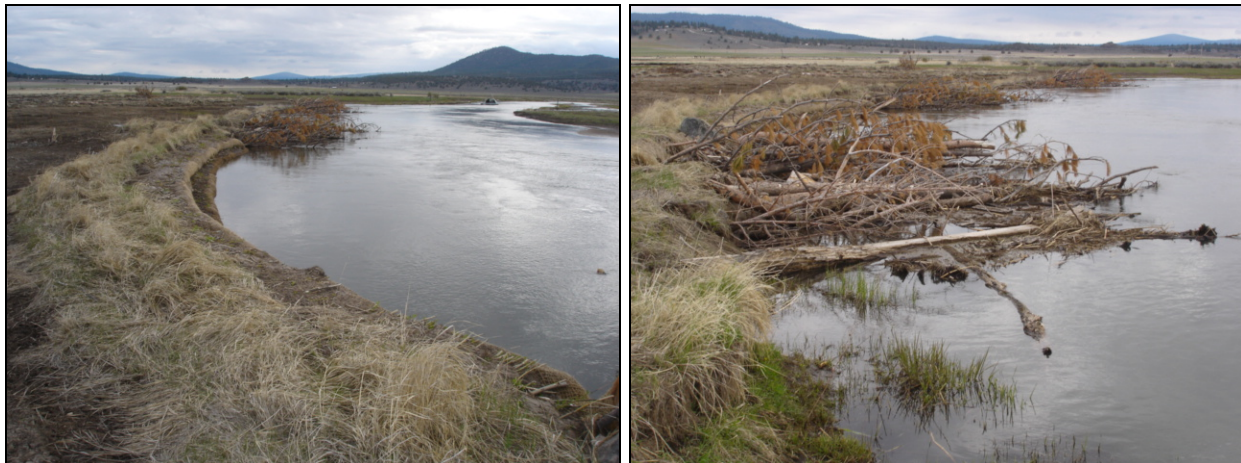
Figure 4-6. Example bioengineering (left) and engineered log jams (right) on the Sprague River. Bioengineering and log jams provide bank stability and diverse aquatic habitat. Over time, the willows planted in the soil lift will form a dense willow thicket.

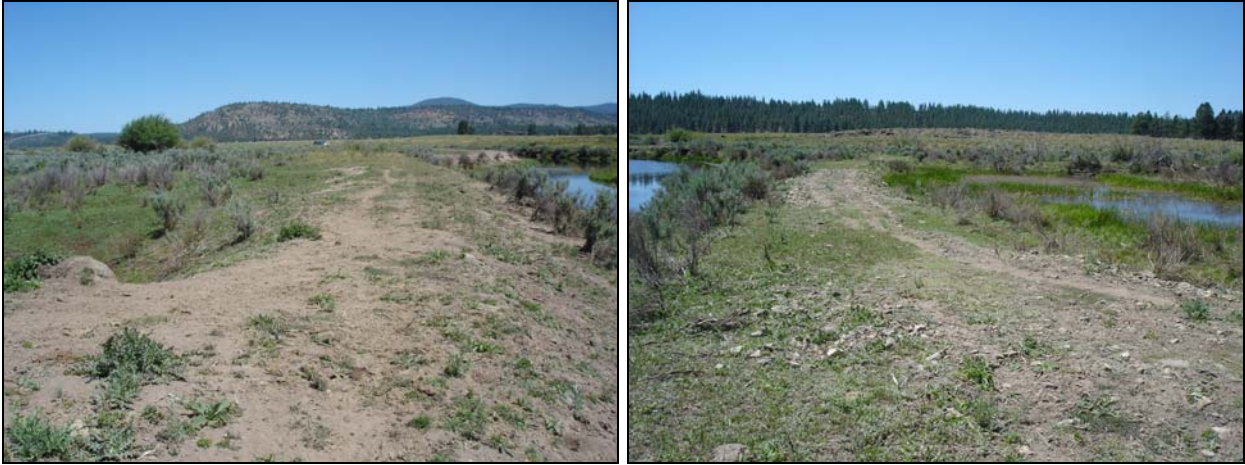
Figure 5-1. Two potential fill removal sites on the Kronenberger reach of the Sycan River. Site 6 (left) is characterized by poor vegetation conditions and floodplain confinement. Site 10 (right) separates the river from an off-channel wetland.

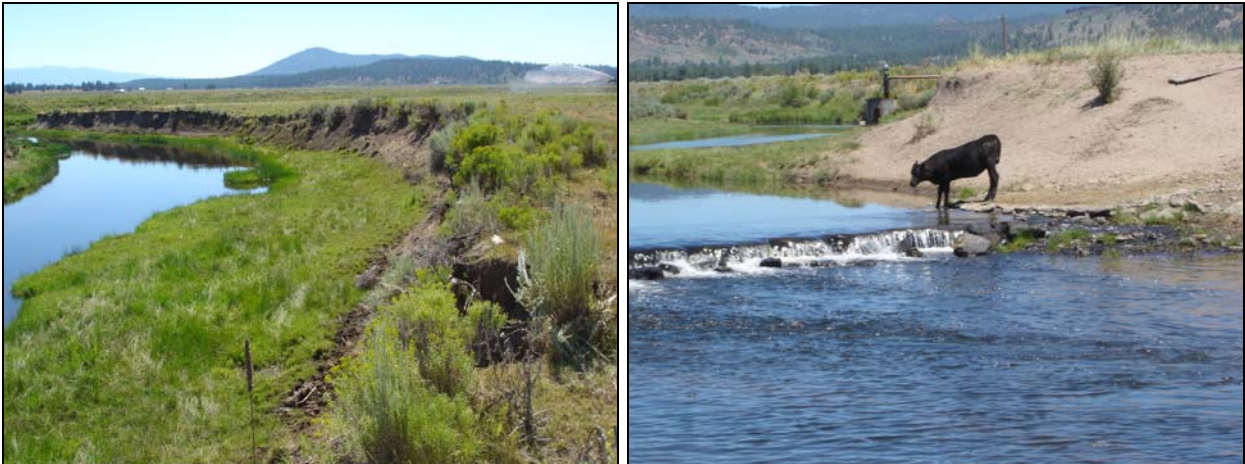
Figure 5-2. A livestock trail at Site 1 (left) results in poor vegetation conditions and a raw bank. The Sycan River crossing (Site 15) concentrates livestock resulting in degraded riparian vegetation and stream bank conditions (right).

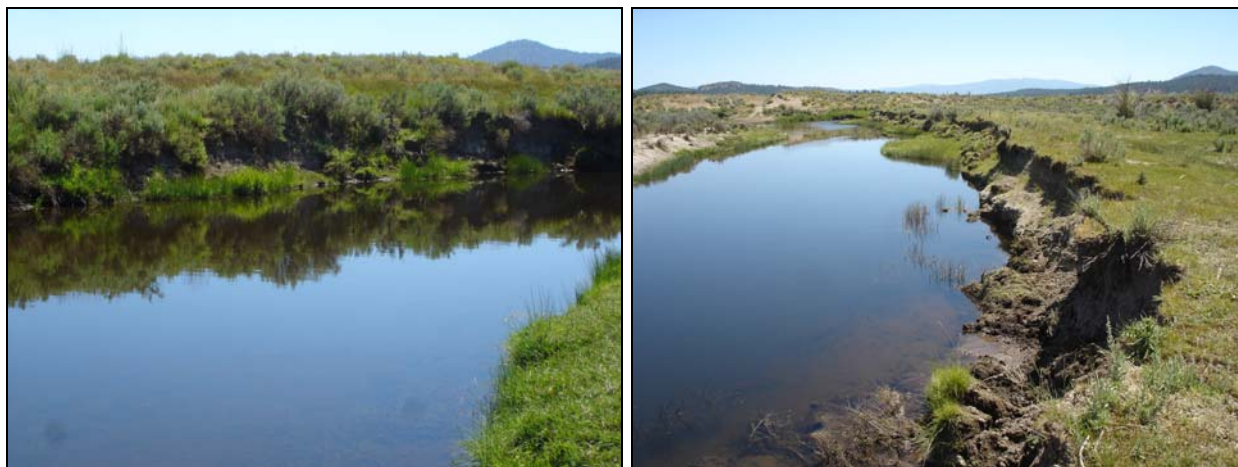
Figure 5-3. Two sites characterized by vertical bank failures related more to fluvial processes than livestock access. Site 4 (left) is a short reach characterized by a vertical-to-overhanging bank. Site 9 is a more extensive reach characterized by an eroding outside bank that is contributing large blocks of soil to the river (right). Sloughed blocks may stabilize at the bank toe and revegetate as seen in the middle ground of the right photo.

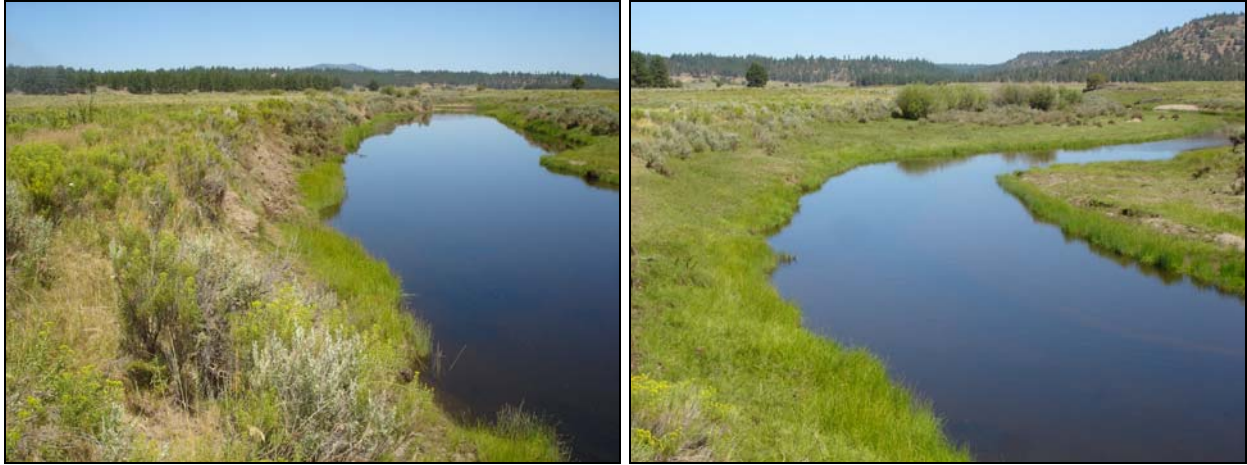
Figure 5-4. An example of an existing eroding bank (left) and a reference condition (right). The stream bank at the reference site has reached an angle of repose that supports vegetation.

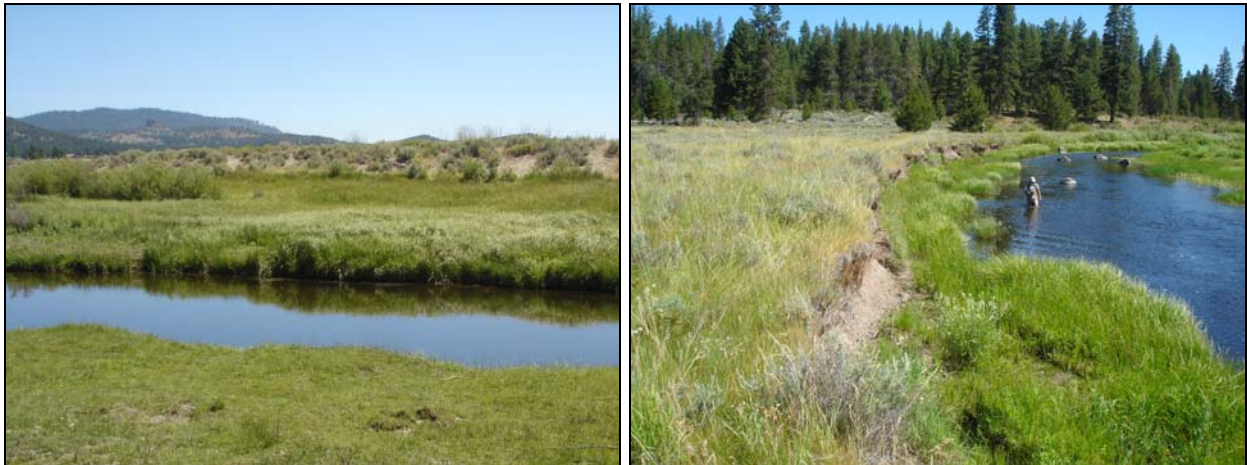
Figure 5-5. Reference vegetation conditions on the Sycan River. A sedge/willow community in the Kronenberger reach (left) and sedges provide a buffer to a previously eroding bank on the Sycan in the Teddy Powers Meadow reach (right). Excluding livestock from the eroding bank sites in the Kronenberger reach would be expected to result in vegetation recovery.

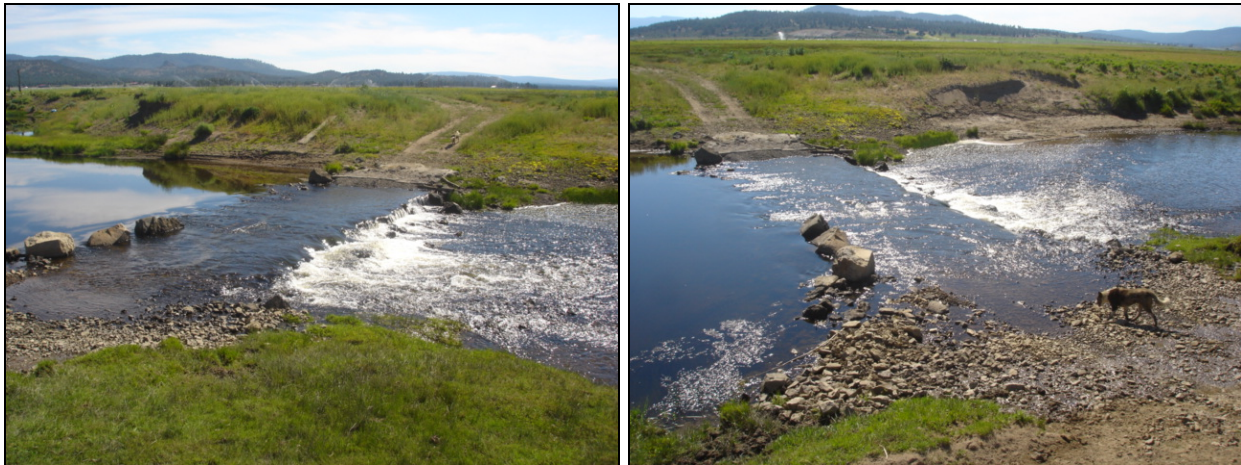
Figure 5-6. The Kronenberger crossing likely creates a fish passage barrier during baseflow. These picture taken in June 2007, capture the structure during the declining hydrograph.

A concrete stream crossing is located in the lower third of the Kronenberger property. The crossing enables Mr. Kronenberger to access the eastern portion of his property. The concrete crossing may affect fish passage during baseflow periods when shallow water depths and vertical height of the structure potentially preclude upstream fish movement (Figure 5-6). The structure is submerged during moderate and high flows. Fish passage is likely not affected during these periods. Although the structure may affect fish passage, it also provides grade control through the reach.

The structure could be modified to improve fish passage. Adding rock or concrete steps to the downstream portion of the structure would provide better fish access over the structure. Building

Figure 5-6. The Kronenberger crossing likely creates a fish passage barrier during baseflow. These picture taken in June 2007, capture the structure during the declining hydrograph.

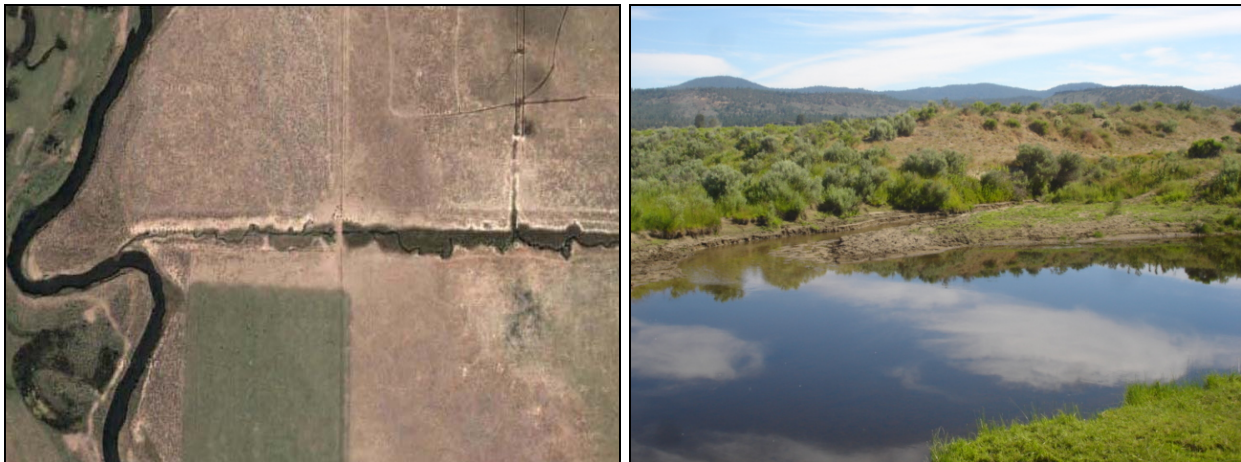
Figure 5-7. An air photo of the drainage channel (left), and a ground photo of the mouth of the drainage channel (right). The channel originates on the Cornelson property and flows through the Kronenberger property before reaching the Sycan River. The drainage channel is a persistent sediment source to the Sycan River.

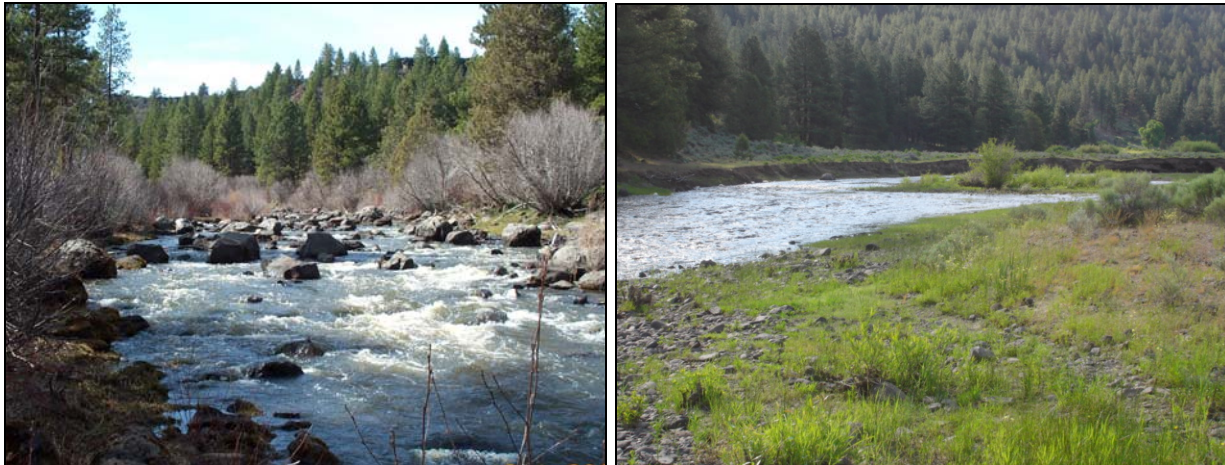
Figure 2-1. River corridor conditions in Reach 1 – Canyon Reach Transition are characterized by a low sinuosity, moderate gradient channel in the Coyote Bucket Canyon (left) to moderate sinuosity, broader river corridor through the river corridor transition (right).

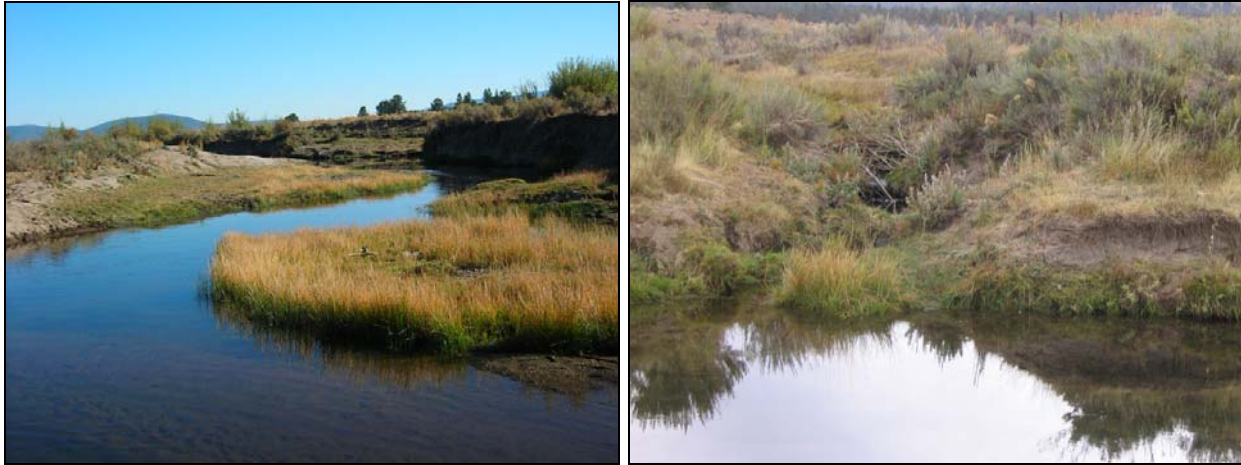
Figure 2-4. Sedges/rushes colonize point bars and confine the baseflow channel inside of the larger active channel bracketed by lateral terraces (left). A beaver dam controls the flow from an off-channel wetland to the Sycan River near Station 152+00 (right).

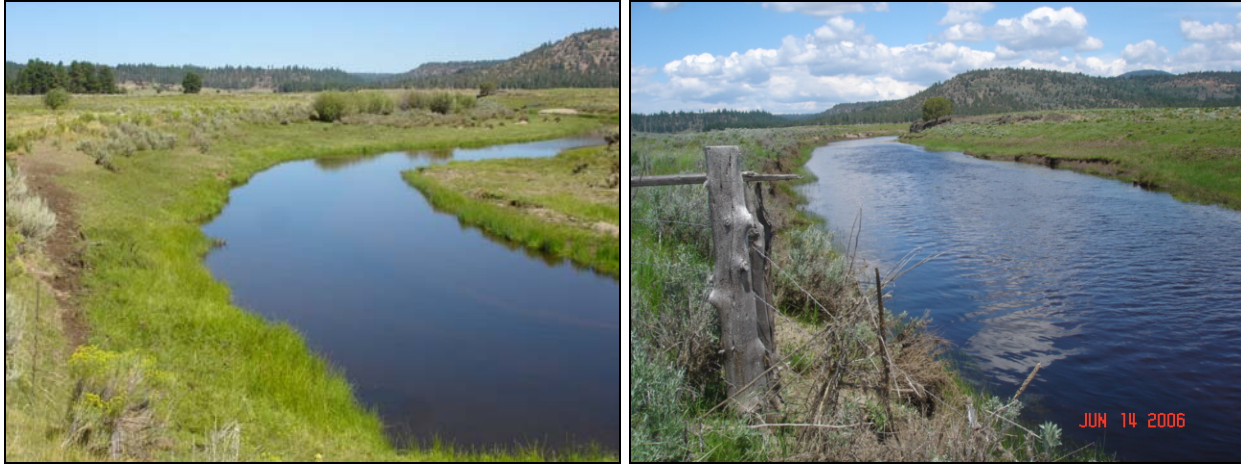
Figure 2-5. River corridor conditions in Reach 5. The channel is confined between lateral terraces. Vegetated surfaces are emergent at base flows (left) are submerged during runoff (right).

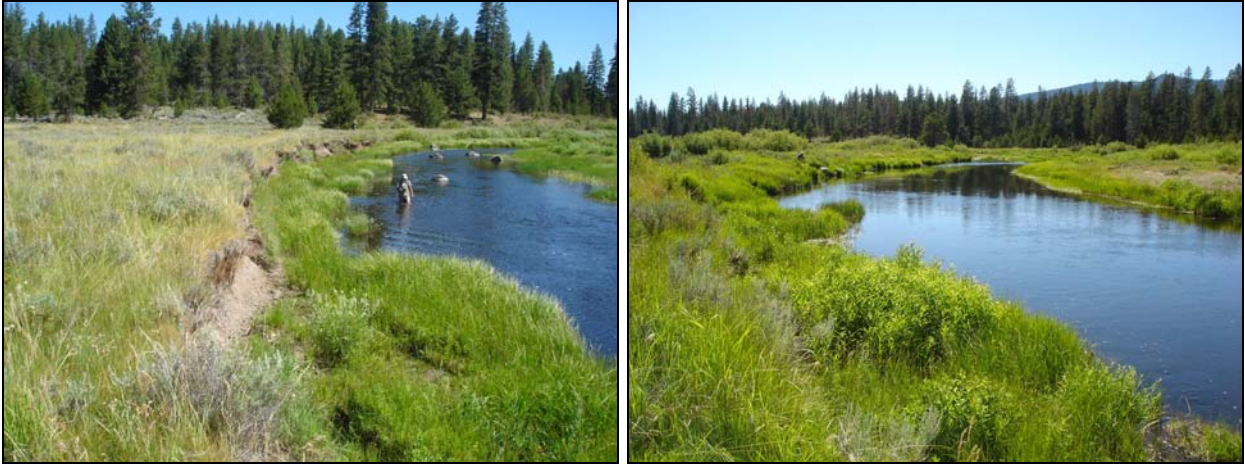
Figure 2-6. Examples of the riparian vegetation communities in the Teddy Powers Meadow reach of the Sycan River. A sedge/rush fringe now buffers the eroding banks from the river (left). Multiple age classes of willows and other riparian vegetation have narrowed the channel and stabilized sediment.

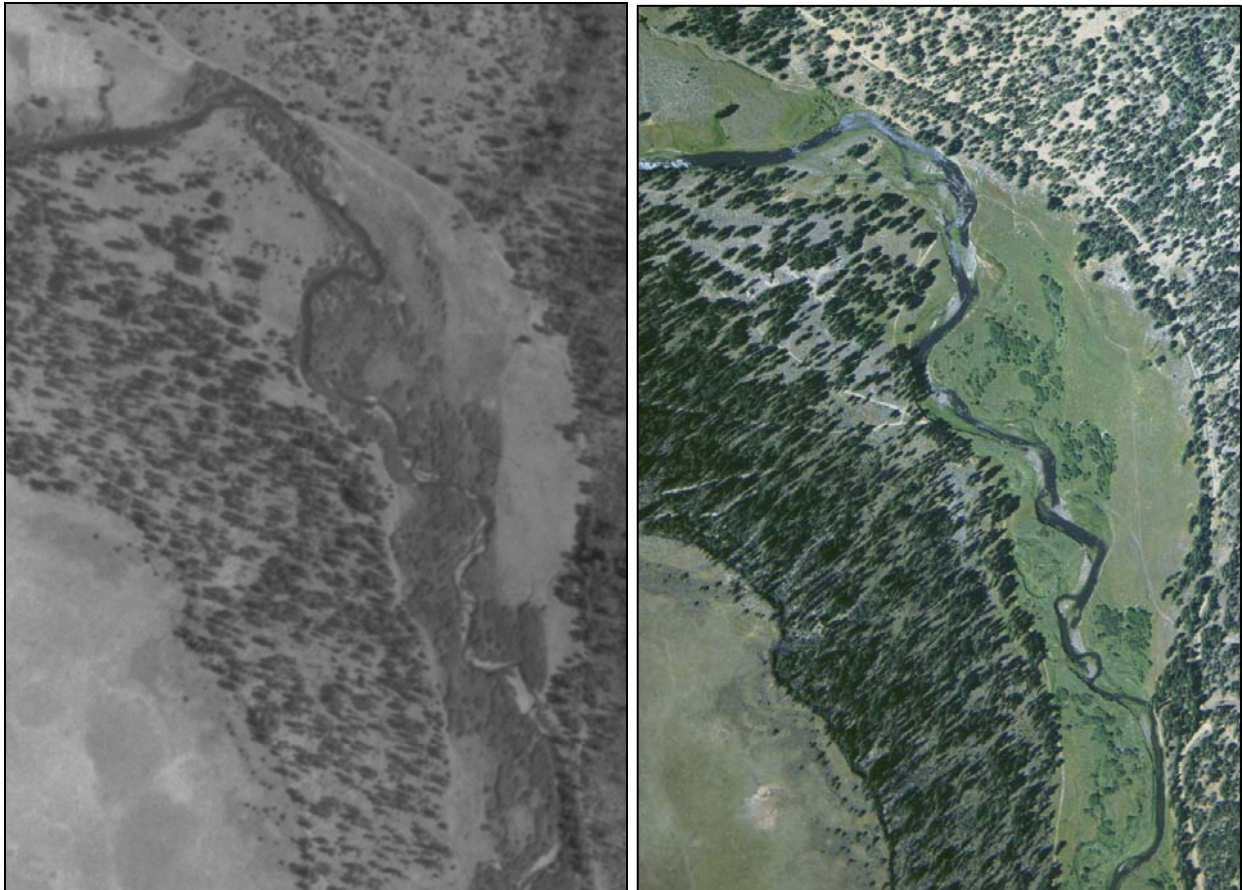
Figure 3-1. A comparison of the Sycan River in Reach 1 and Reach 2 in 1941 (left) and 1998 (right). The riparian community has become less dense and the river straighter over time.

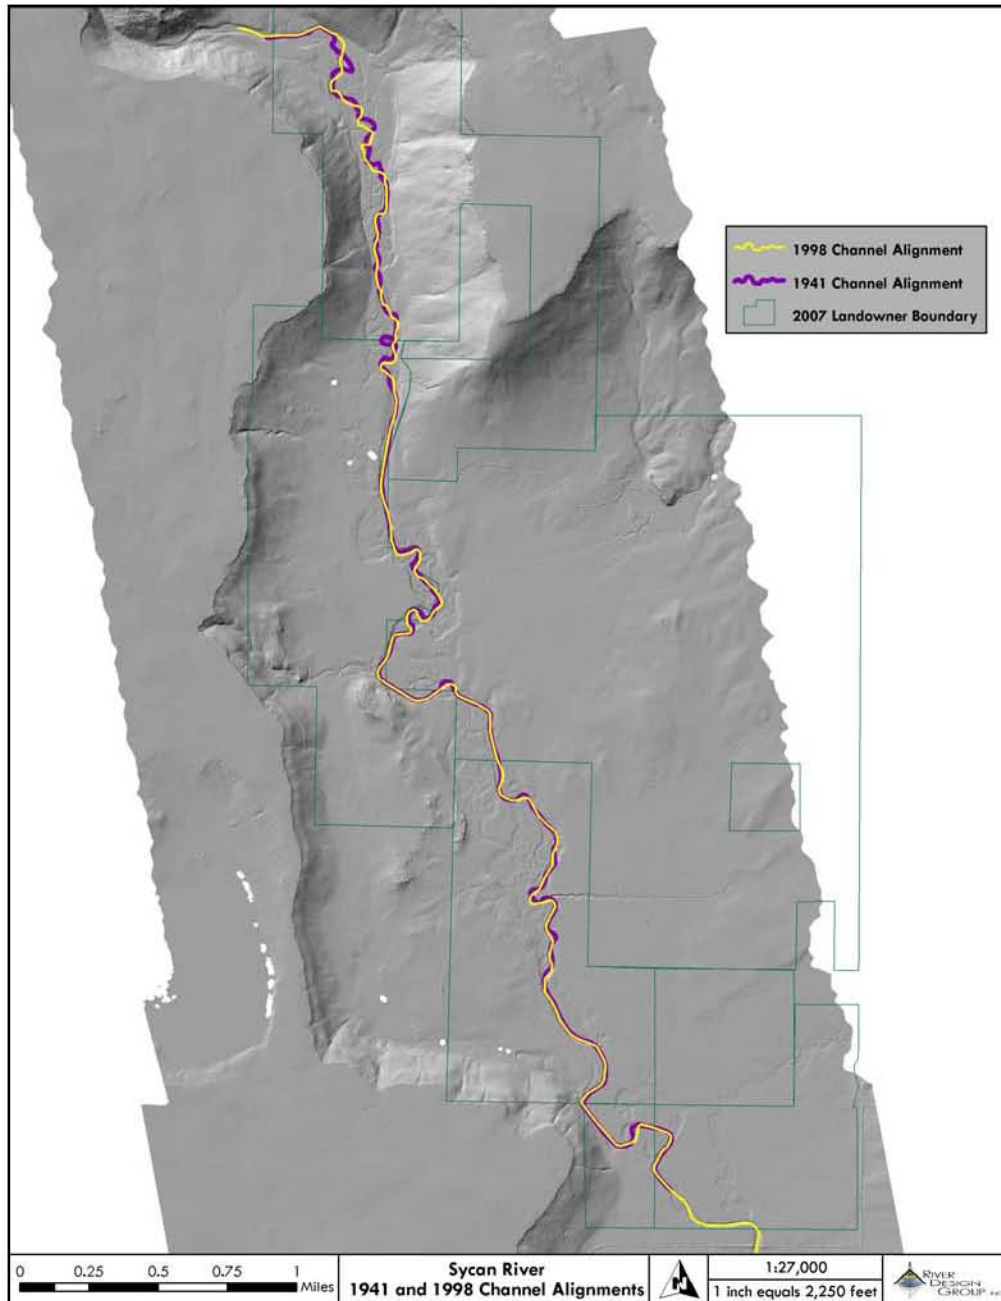
Figure 3-2. The 1941 and 1998 channel alignment locations relative to the 2007 landownership map.

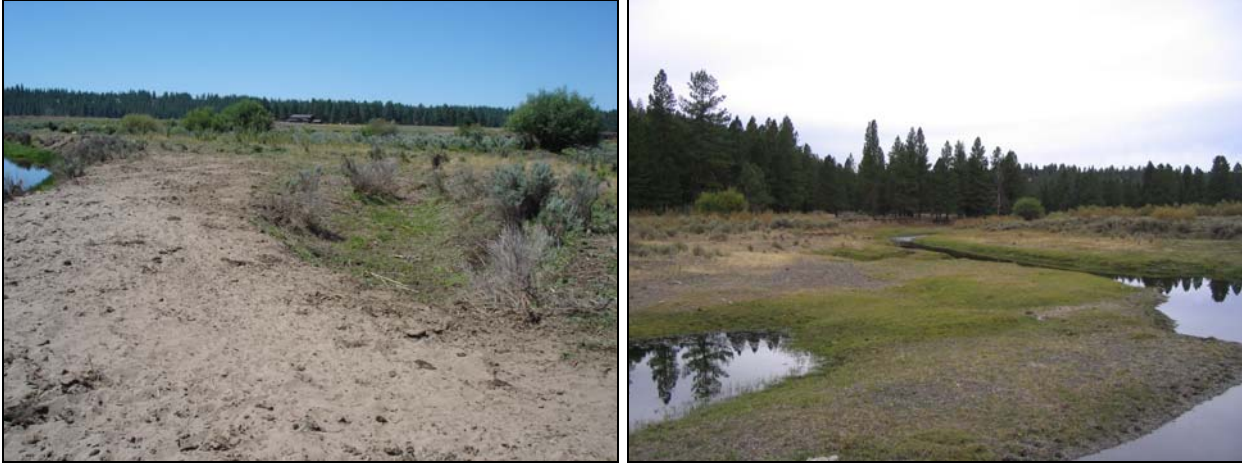
Figure 3-3. Examples of grazing impacts on the Sycan River floodplain in the project area. Repeated trampling of floodplain areas (left) and grazing vegetation within the active channel corridor have led to channel instability.

Livestock effects on the river corridor includes vegetation removal, land surface compaction, and streambank trampling. Vegetation removal is most prominent on land surfaces paralleling the low flow channel. Although these areas are submerged during high flows, sedges, rushes, and willows colonize these sites. These species provide high quality forage proximate to a water source. Grazing of this vegetation is believed to have modified the Sycan River's resistance to bank erosion and contributed to channel instability. Near-bank vegetation that would increase sediment retention and promote streambank building has been lost from much of the upper project area. Grazing on floodplain and terraces has lead to soil compaction. Compacted surfaces decrease surface permeability and promote surface water routing. Disturbed surfaces are also more susceptible to noxious weed invasion. Cattle trampling of streambanks increases bank instability and erosion (Figure 3-3). Repeated trampling related to travel routes breakdown banks and decrease vegetation diversity.

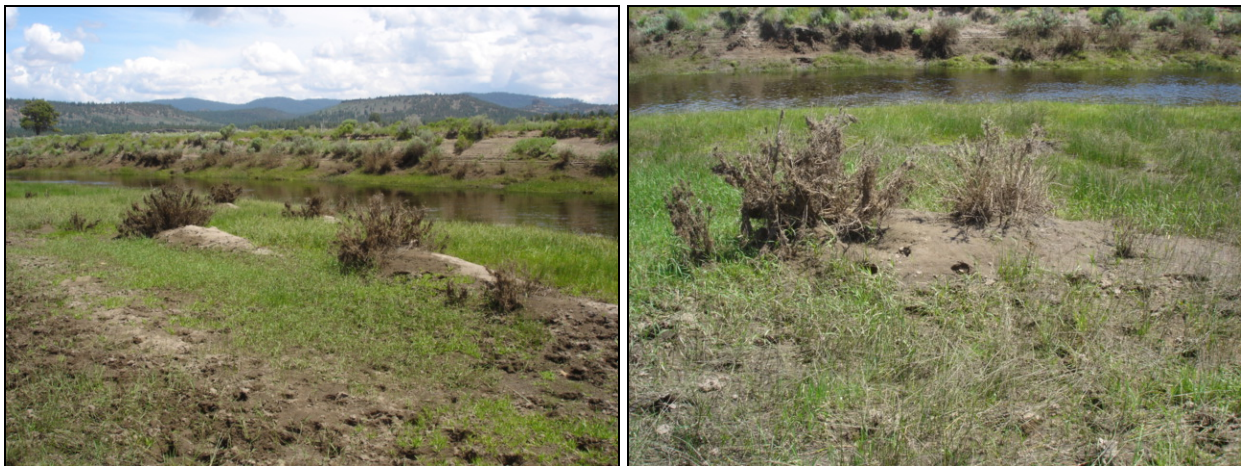
Figure 3-4. Two examples of the influence of riparian vegetation on sediment trapping on the Sycan River illustrate the role of floodplain vegetation in storing fine sediment. Silver sagebrush on the floodplain creates turbulence and sediment deposition. If left undisturbed over time, these sites would be colonized by vegetation and bank building would take place.
