SYCAN RIVER ASSESSMENT AND RESTORATION FEASIBILITY STUDY

August 30, 2007

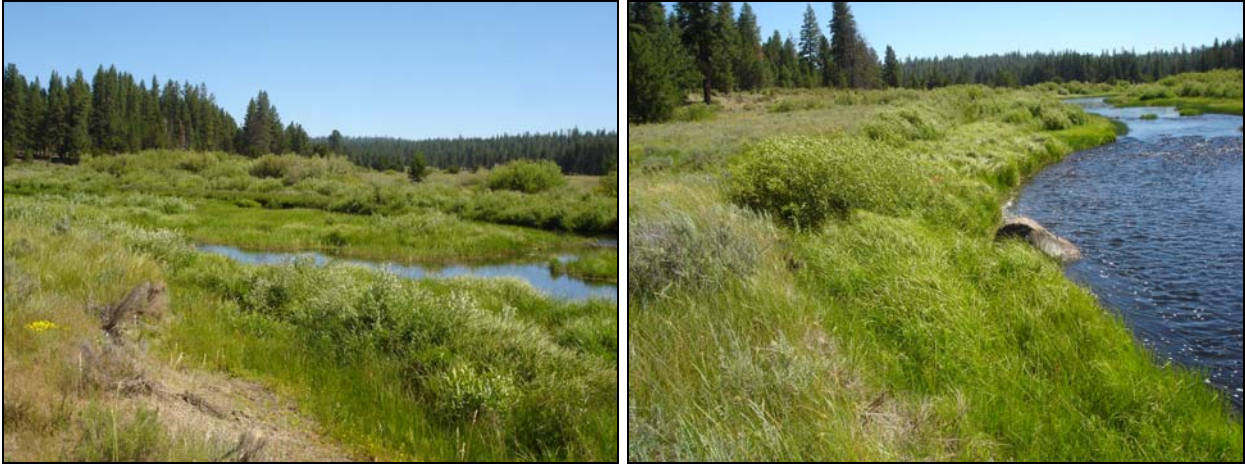
Figure 3-5. Riparian vegetation in the Teddy Powers Meadows reference reach is characterized by sedges/rushes at the channel edge grading to willows at the edge of the active flood channel. Sage brush and other drier upland species occupy the low terrace.

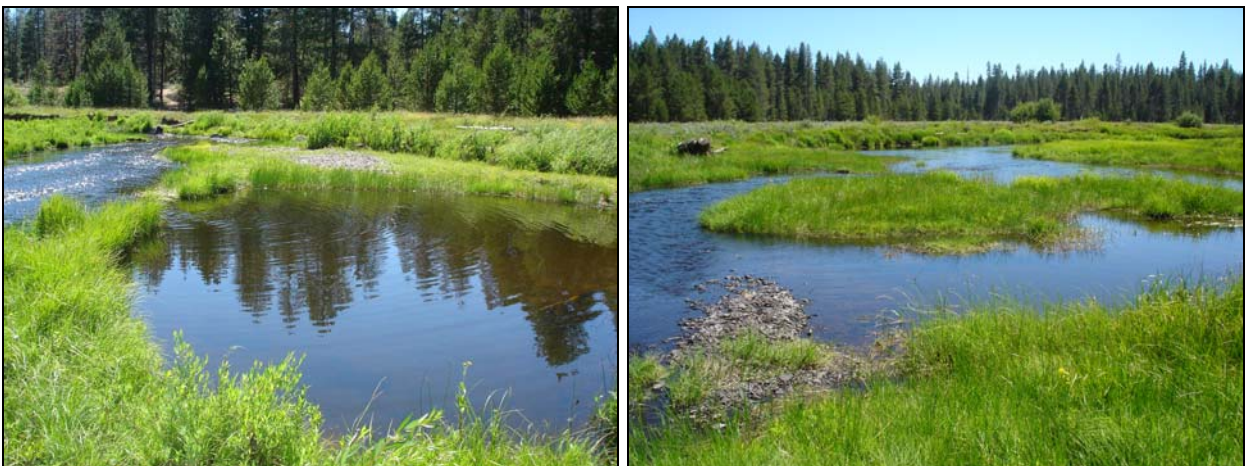
Figure 3-6. River corridor habitats including a floodplain pond (left) and side channels contribute to aquatic habitat diversity in the reference reach. Several features appear to have been influenced by beavers.

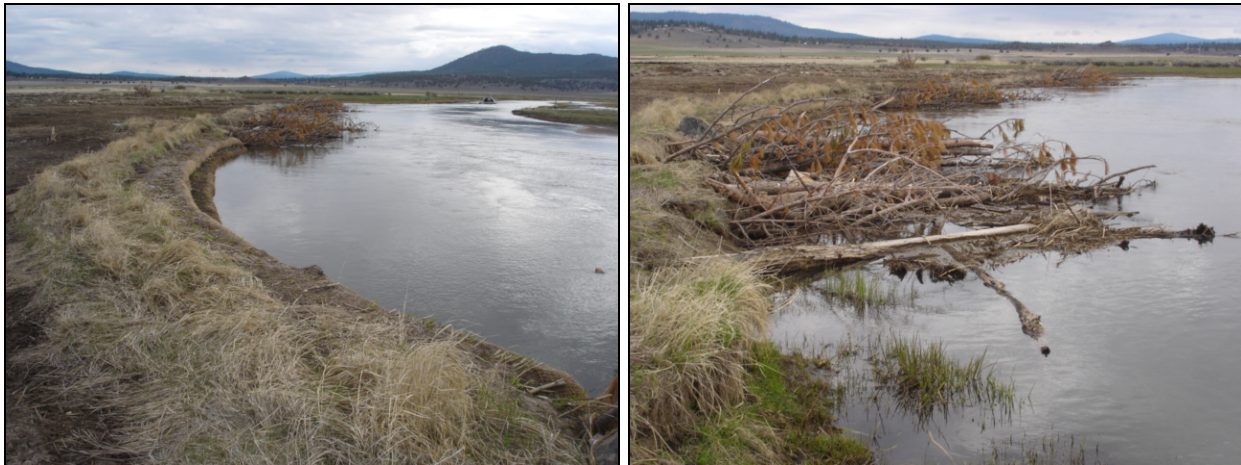
Figure 4-6. Example bioengineering (left) and engineered log jams (right) on the Sprague River. Bioengineering and log jams provide bank stability and diverse aquatic habitat. Over time, the willows planted in the soil lift will form a dense willow thicket.

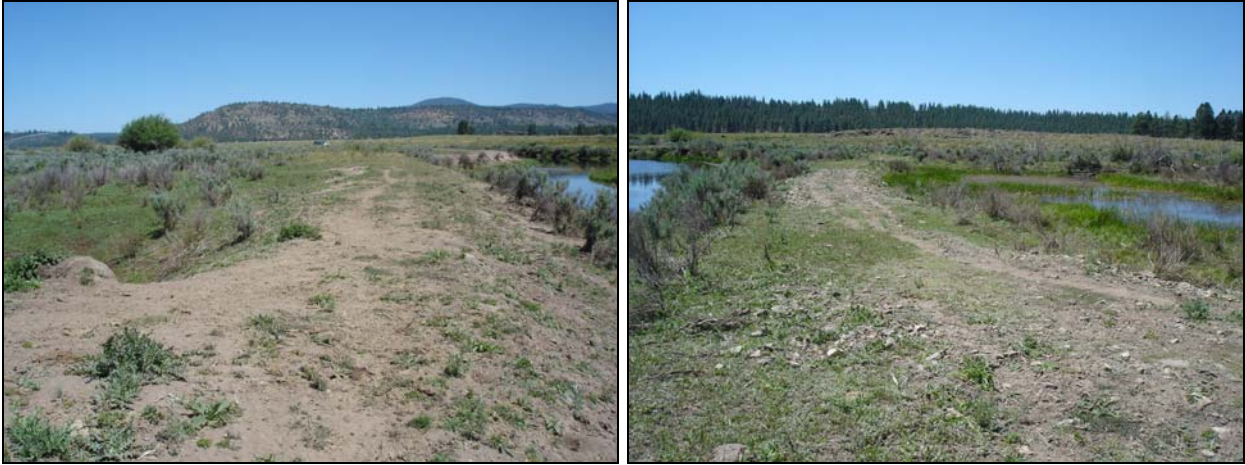
Figure 5-1. Two potential fill removal sites on the Kronenberger reach of the Sycan River. Site 6 (left) is characterized by poor vegetation conditions and floodplain confinement. Site 10 (right) separates the river from an off-channel wetland.

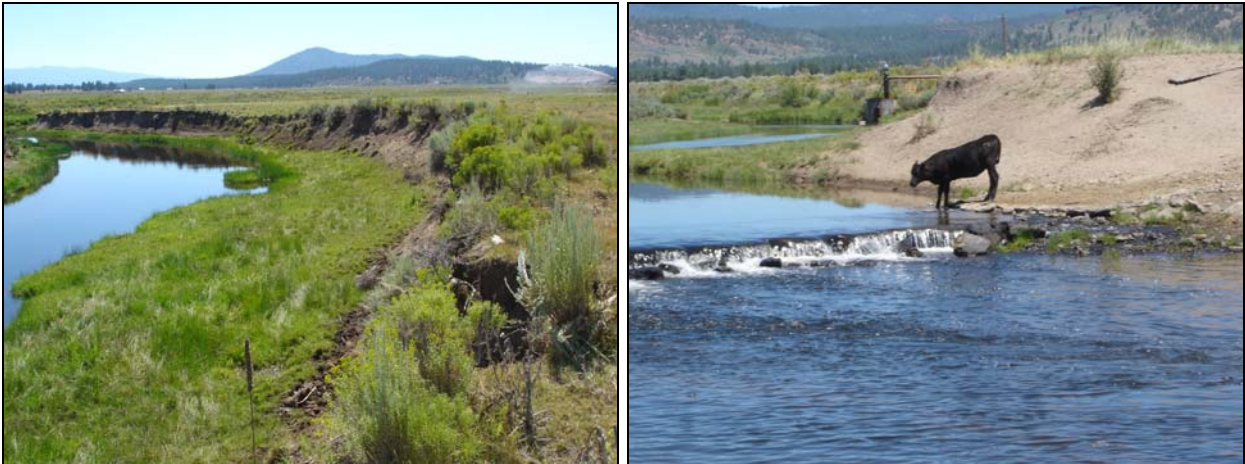
Figure 5-2. A livestock trail at Site 1 (left) results in poor vegetation conditions and a raw bank. The Sycan River crossing (Site 15) concentrates livestock resulting in degraded riparian vegetation and stream bank conditions (right).

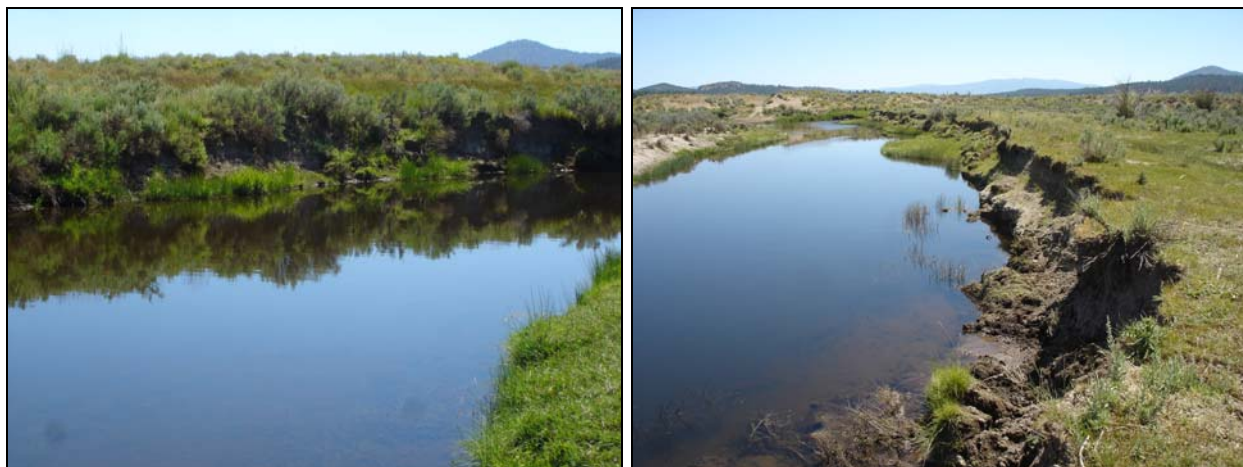
Figure 5-3. Two sites characterized by vertical bank failures related more to fluvial processes than livestock access. Site 4 (left) is a short reach characterized by a vertical-to-overhanging bank. Site 9 is a more extensive reach characterized by an eroding outside bank that is contributing large blocks of soil to the river (right). Sloughed blocks may stabilize at the bank toe and revegetate as seen in the middle ground of the right photo.

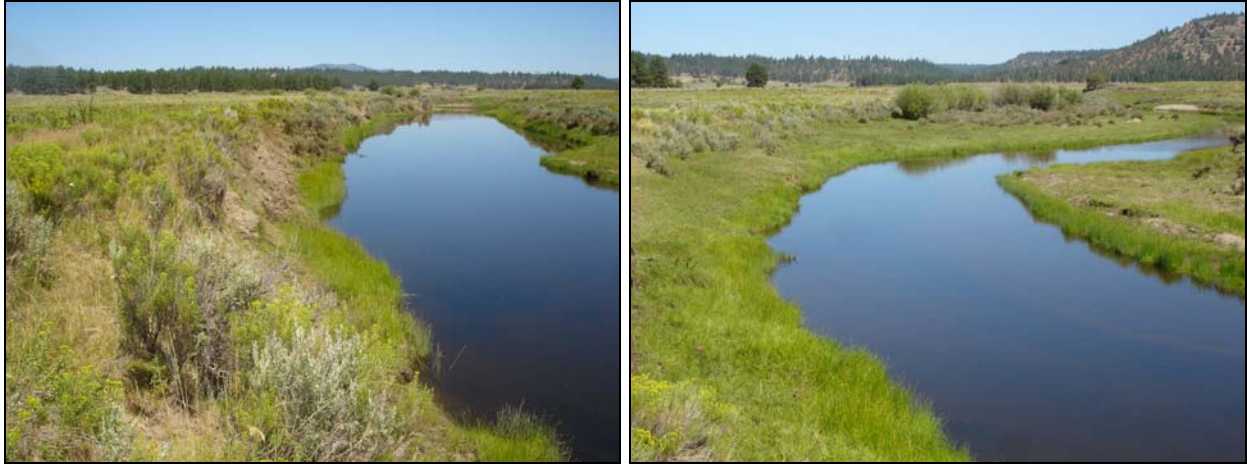
Figure 5-4. An example of an existing eroding bank (left) and a reference condition (right). The stream bank at the reference site has reached an angle of repose that supports vegetation.

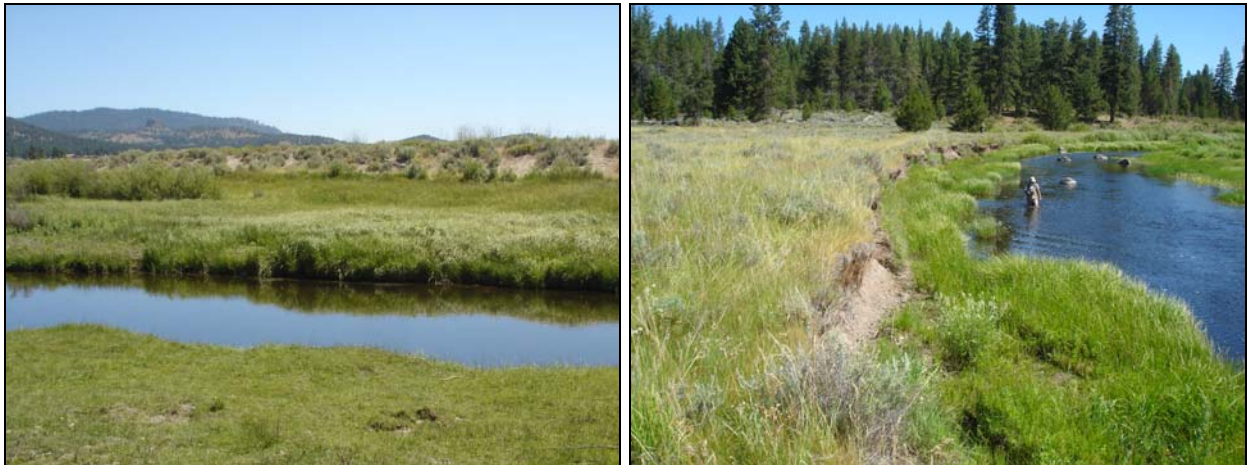
Figure 5-5. Reference vegetation conditions on the Sycan River. A sedge/willow community in the Kronenberger reach (left) and sedges provide a buffer to a previously eroding bank on the Sycan in the Teddy Powers Meadow reach (right). Excluding livestock from the eroding bank sites in the Kronenberger reach would be expected to result in vegetation recovery.

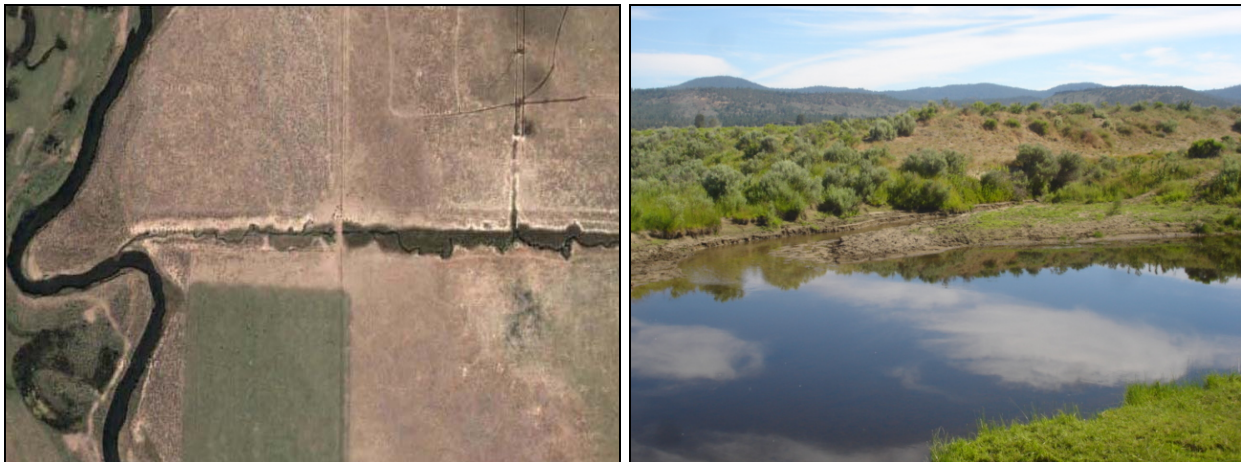
Figure 5-7. An air photo of the drainage channel (left), and a ground photo of the mouth of the drainage channel (right). The channel originates on the Cornelson property and flows through the Kronenberger property before reaching the Sycan River. The drainage channel is a persistent sediment source to the Sycan River.

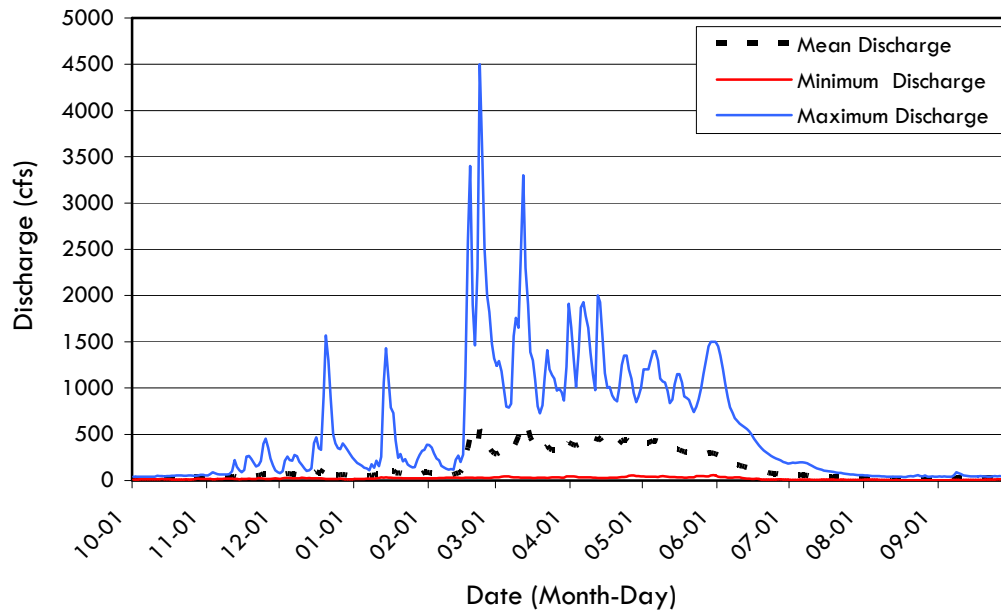
Figure A-1. The average annual hydrograph for the Sycan River at Drews Road. The period of record is from 1978 to 1990.

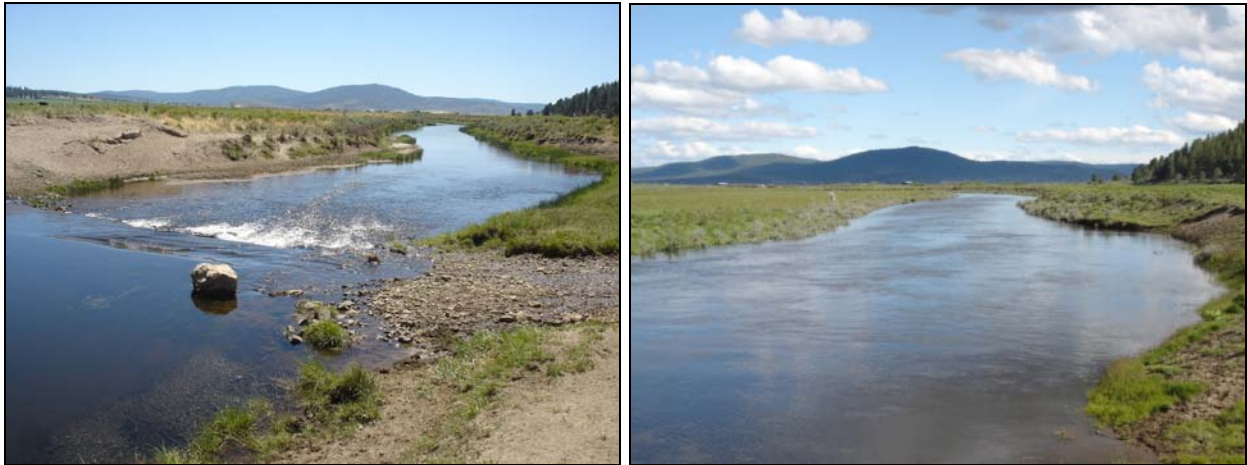
Figure A-3. River corridor condition comparison between summer time base flows (left) and spring runoff (right). High water limits big sagebrush and bitterbrush encroachment into the channel.

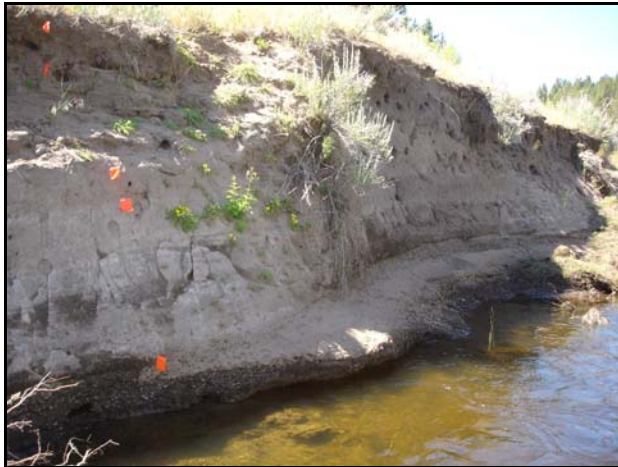
Figure B-2. Two bank profiles on the Sycan River in the project area (top) and the Teddy Powers Meadows reference reach (bottom) exhibit similar soil stratigraphy. However, the depth of pumice is substantially deeper in the project area relative to the upstream reference reach.

Pin flags located in each bank mark changes in soil composition, texture, or color. The project area bank was characterized by a thin layer of organic matter overlaying multiple layers of pumice-derived materials. The bottom pin flag notes the top of the gravel channel bed that likely marks the historical channel bed.

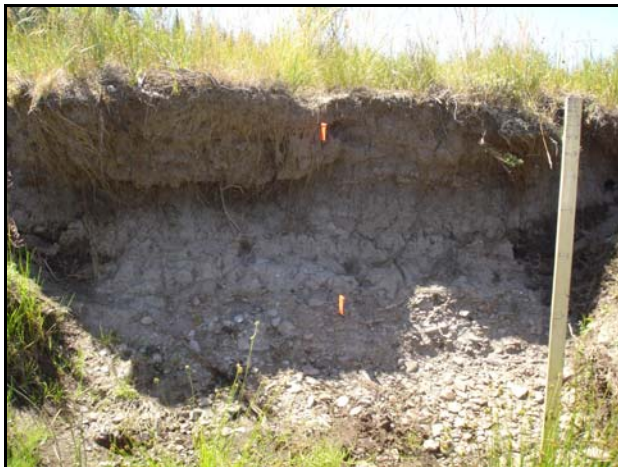
Pin flags note similar soil changes in the bank stratigraphy in the Teddy Powers Meadows reach. The Teddy Powers Meadows streambank had a lower bank height and less distance between the top of bank and the gravel bed. Bank materials were also more consistent with a thicker organic layer and two lower pumice layers. Bank stratigraphy differences suggest less pumice delivery occurred in the Teddy Powers Meadows reach compared to the project area.

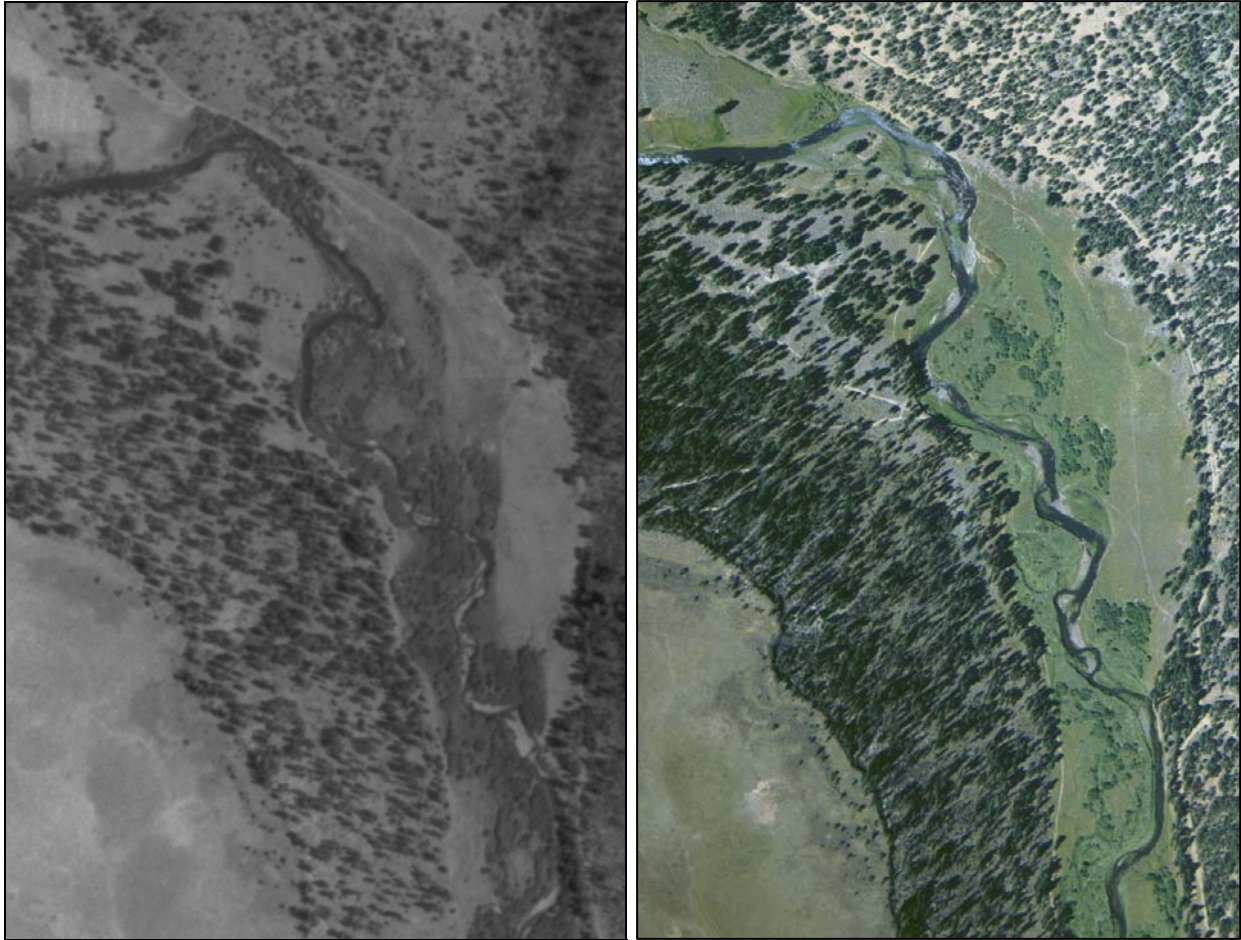
Figure B-3. A comparison of the Sycan River in Reach 1 and Reach 2 in 1941 (left) and 1998 (right). The riparian community has become less dense and the river straighter over time.

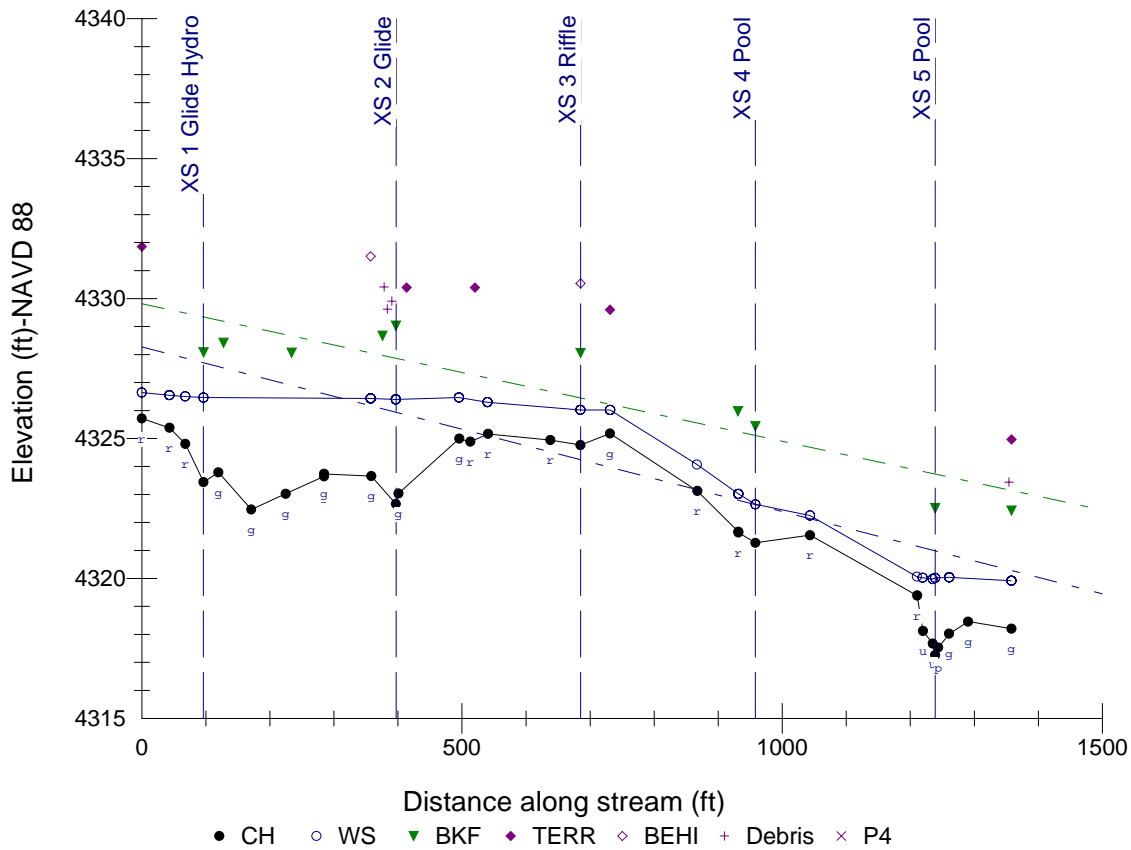
Figure B-8. The Reach 1 longitudinal channel profile graph with GPS-survey cross-section locations.

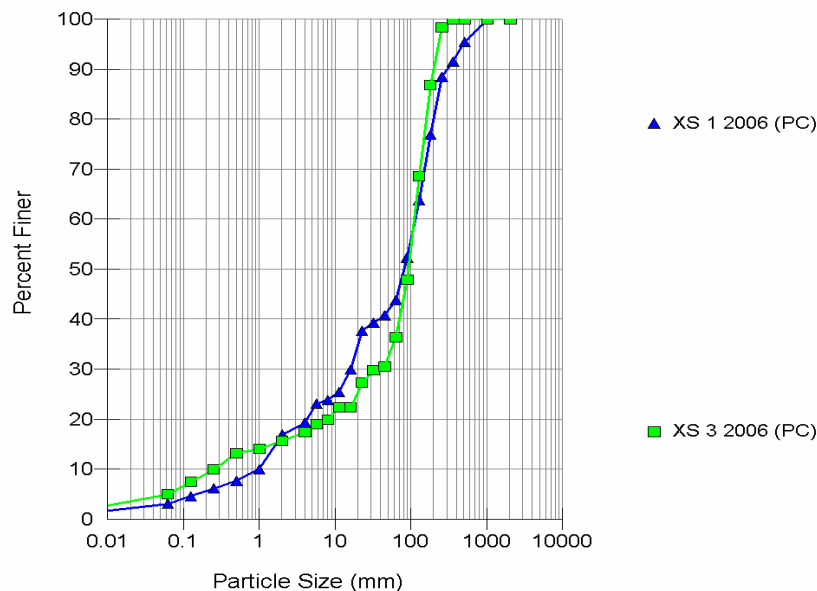
**Figure B-10.** Pebble count particle size gradation curve for R1 XS1-Glide and R1 XS3-Riffle.

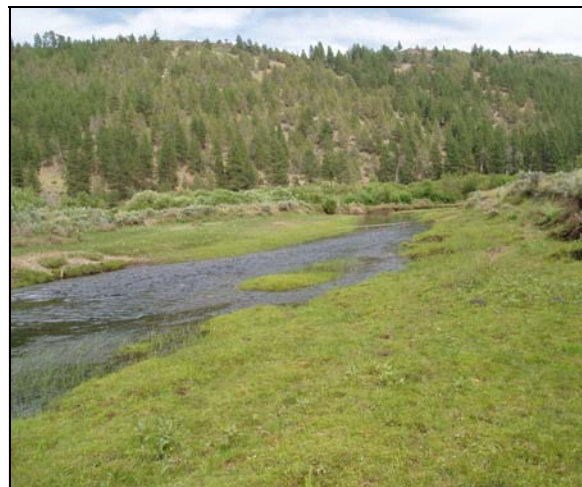
Figure B-11. The channel cross-section (left) and site photo (right) for XS2-Riffle/Run in Reach 2.

Figures B-11 through B-12 include the channel cross-section diagrams and site photographs.

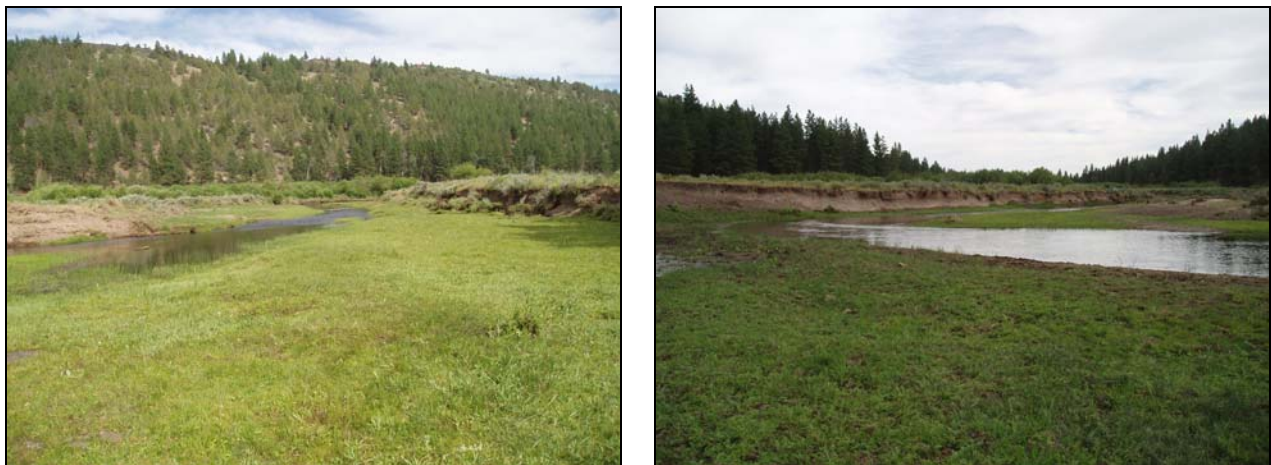
Figure B-13. Project Reach 2 straight riffle section (left) and downstream meander pool sequence (right) illustrate existing channel conditions within the active channel.

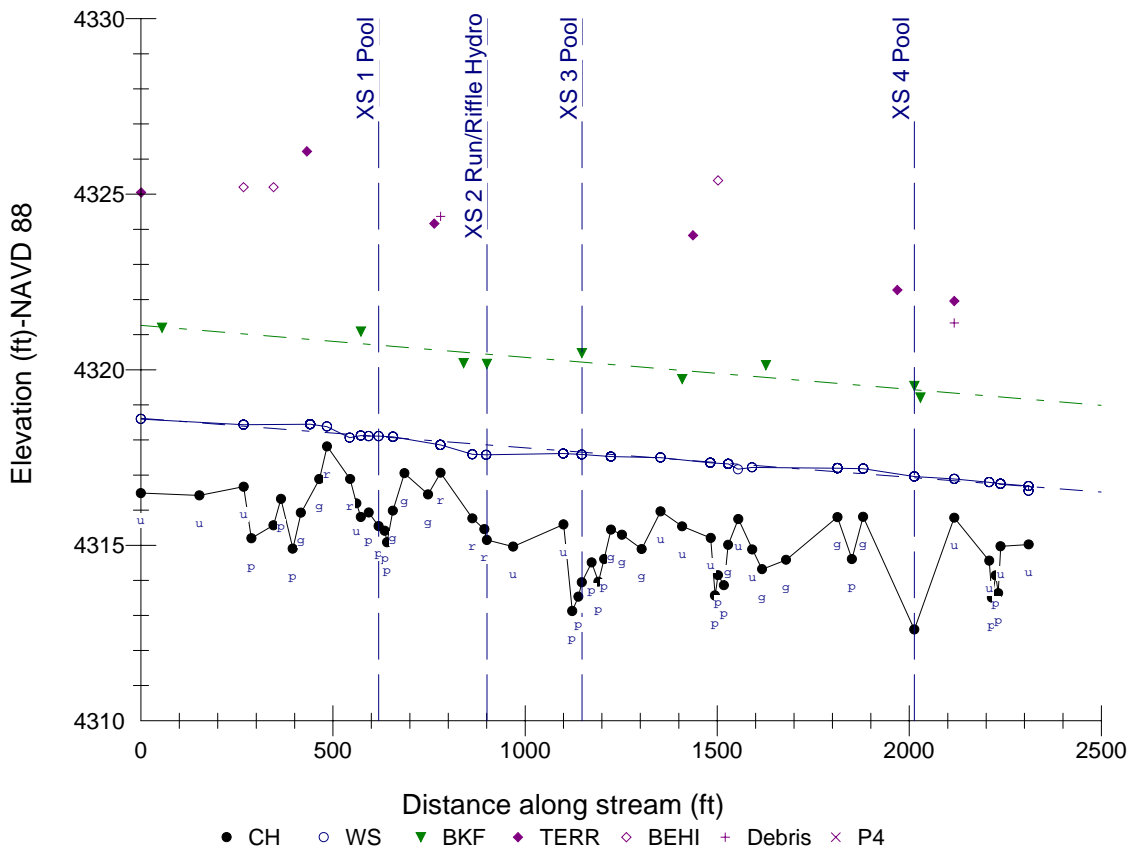
Figure B-14. The Reach 2 longitudinal channel profile graph with GPS-survey cross-section locations.

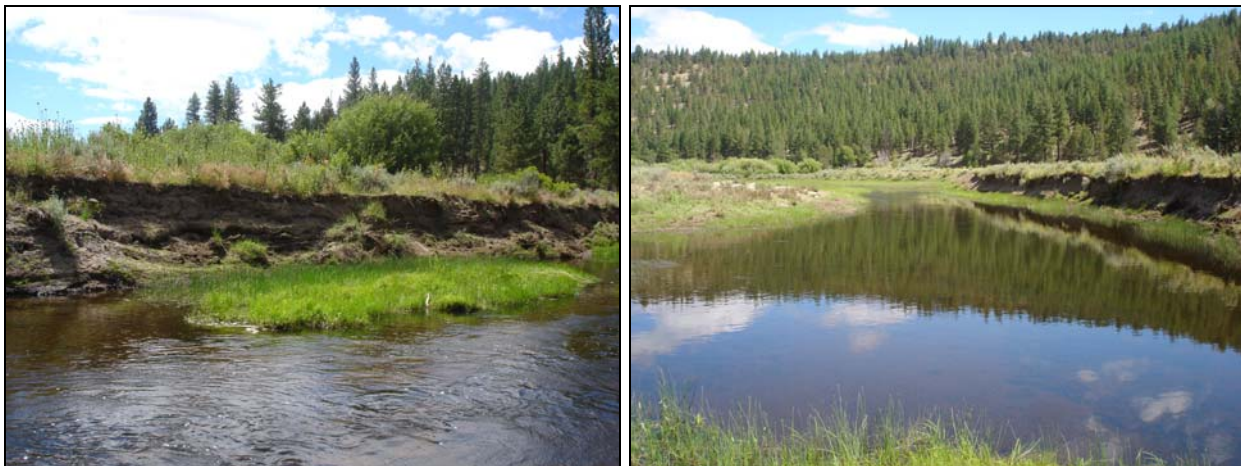
Figure B-15. Example bank conditions in Reach 2.

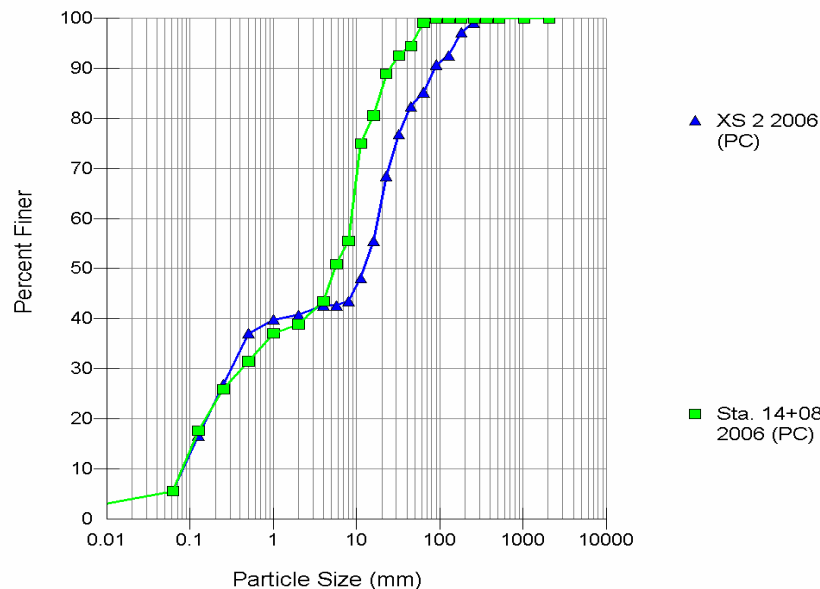
Figure B-16. Pebble count particle size gradation curve for R2 XS2-Glide and LID R2 XS2-Riffle.

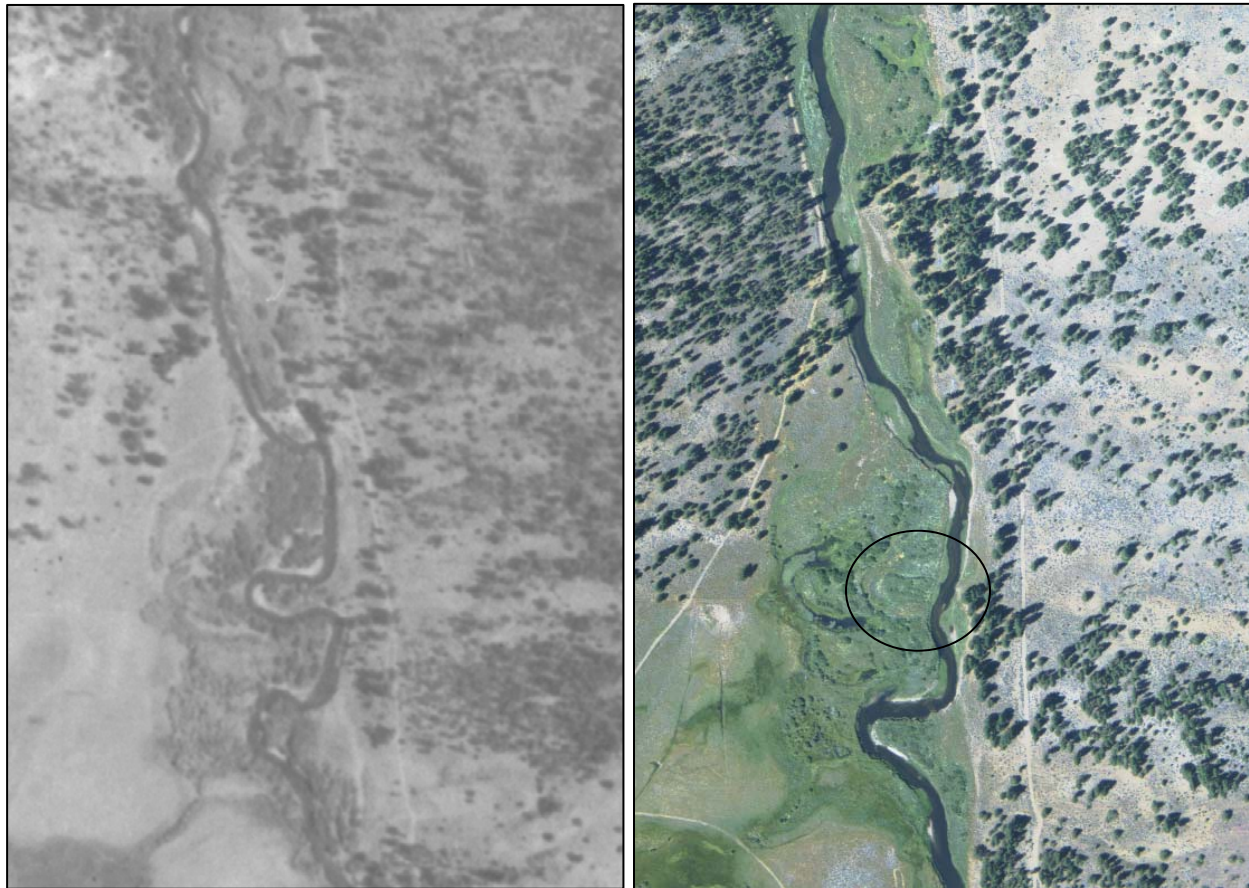
Figure B-17. A channel meander (circled) that was active in the 1941 air photo (left) was abandoned by the 1998 air photo (right). The abandoned channel segment remains apparent on the landscape although it is located above the current alignment's elevation, suggesting the channel has degraded in the reach since 1941.

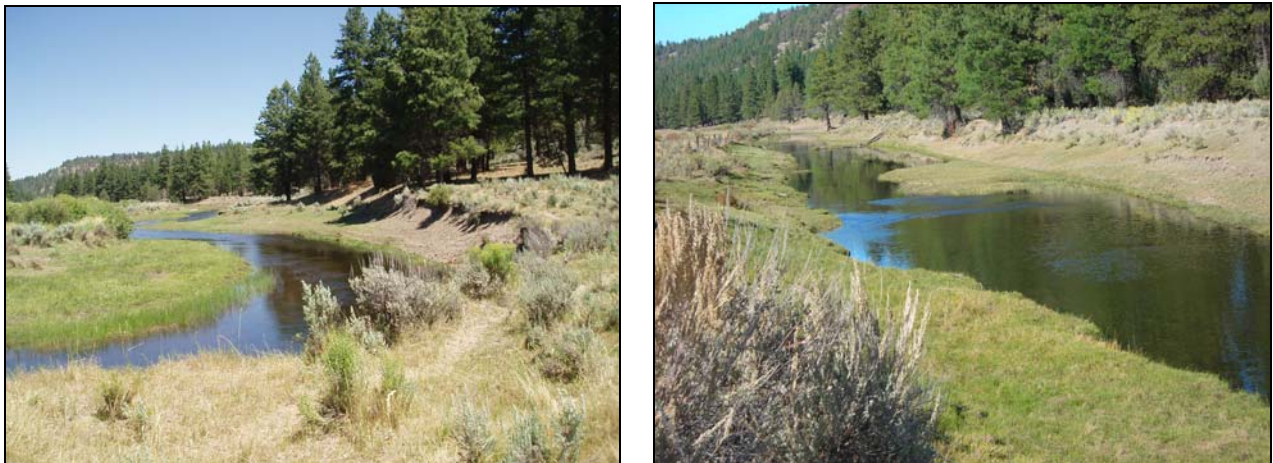
Figure B-20. Reach 3 site conditions include the Sycan River upstream from the eroding bank at Station 97+00 (left) and in the vicinity of Station 122+00 (right). The channel is entrenched through the lower half of the reach. The Sycan River is confined by the western terrace and the eastern hillslope.

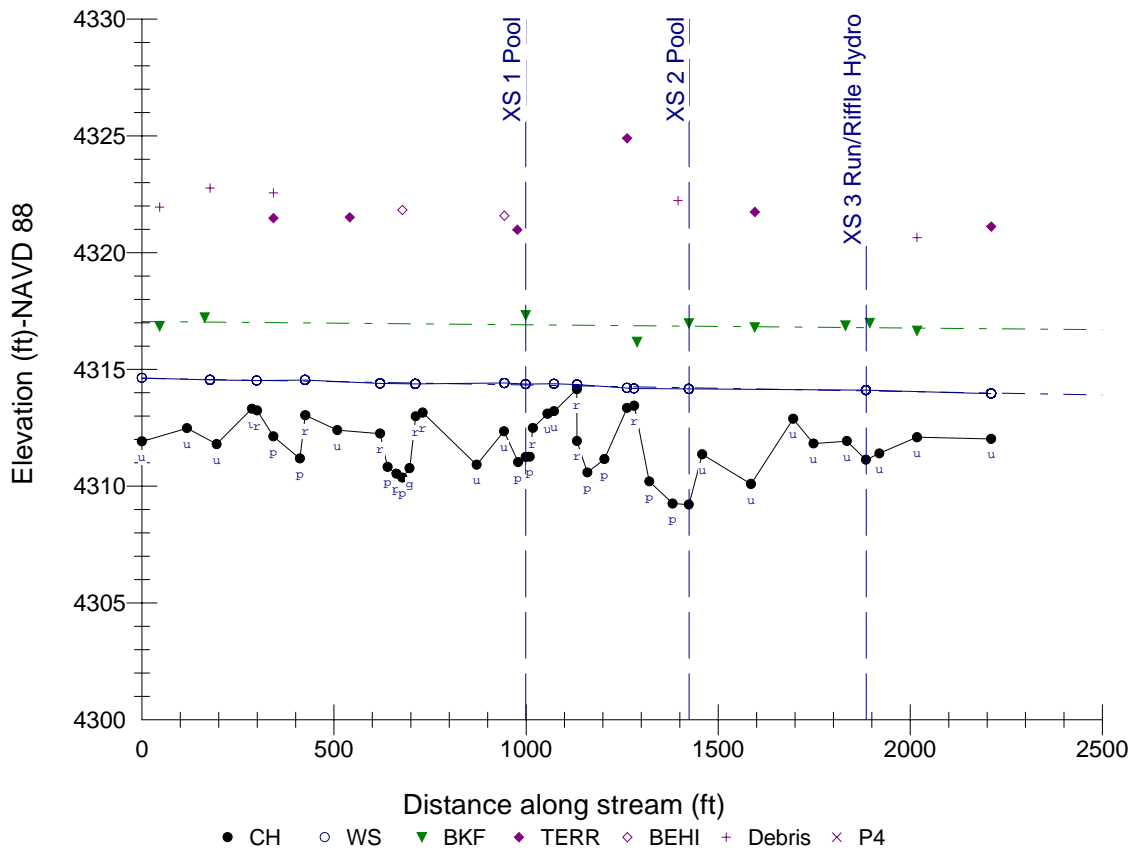
Figure B-21. The Reach 3 longitudinal channel profile graph with GPS-survey cross-section locations.

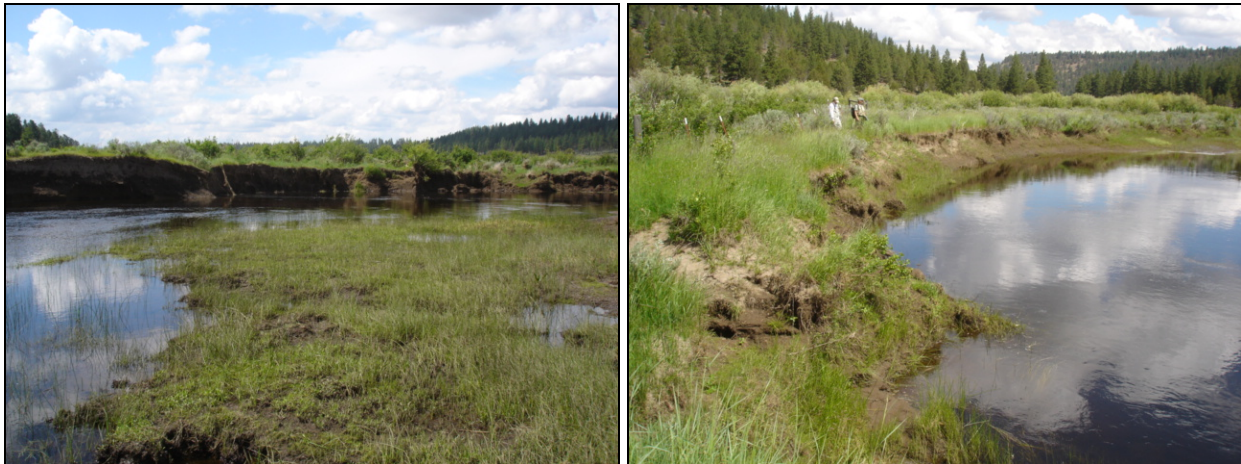
Figure B-22. Example bank conditions in Reach 3. Severe bank erosion from Station 97+00 to 99+00 (left) suggests continued down valley meander migration.

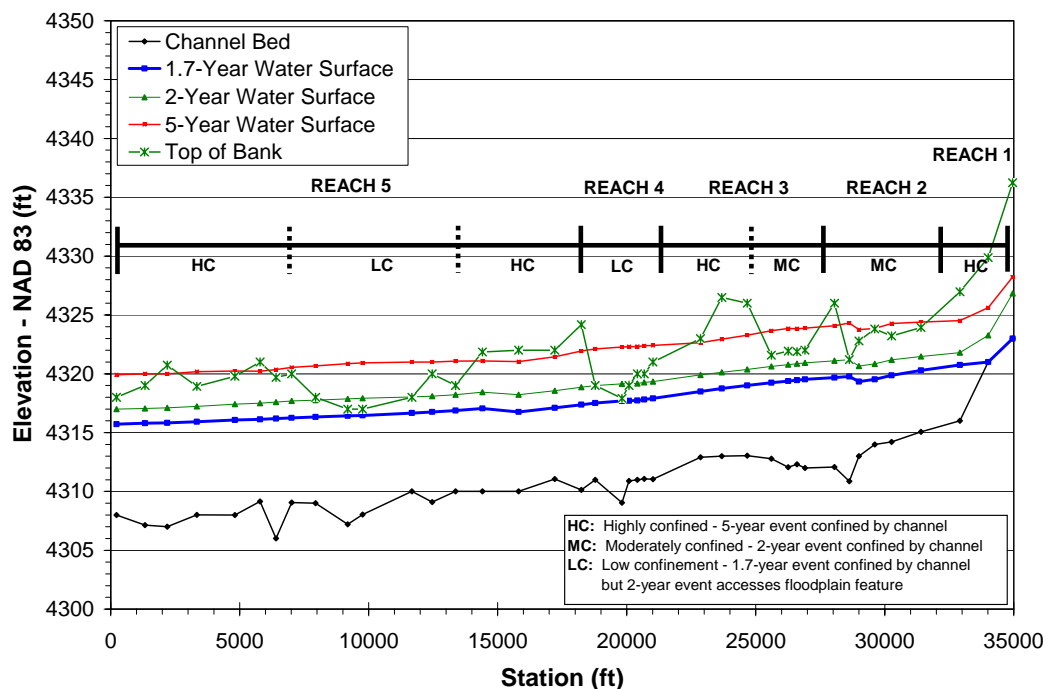
Figure E-5. Water surface elevations associated with the modeled return interval events with a Manning's-n value of 0.030. Reach breaks and degree of channel confinement are also noted.

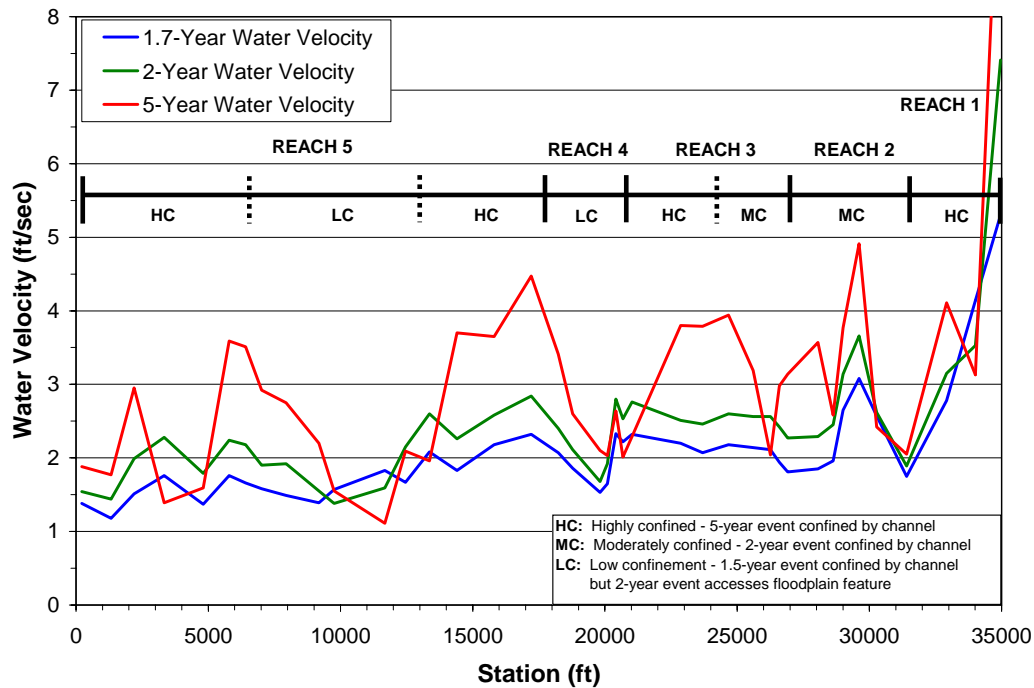
Figure E-6. Average water velocities associated with the modeled return interval events with a Manning's-n value of 0.030. Reach breaks and degree of channel confinement are also noted.

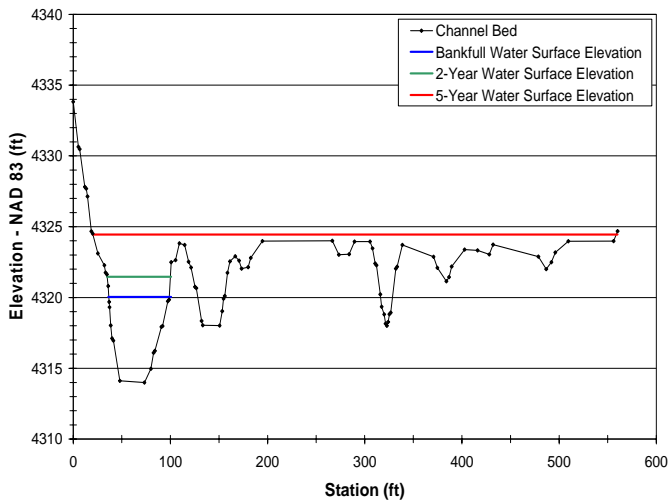
Figure E-7. The hydraulic channel cross-section at Station 29613 (left) and an air photo of the reach at a 2.4-year event on April 12, 2006 (right). The modeled cross-section suggests that over a 2-year discharge is contained within the channel.

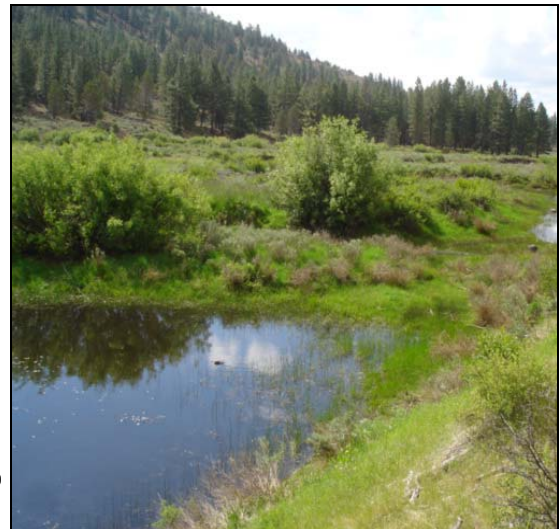
Figure E-8. The hydraulic channel cross-section at Station 28628 (left) and a ground photo taken in June 2006 after recession of peak flows (right). The modeled cross-section suggests that the 2-year event accesses floodplain channels. The valley bottom is inundated during a 5-year event. Floodplain channels hold water through spring and early summer.

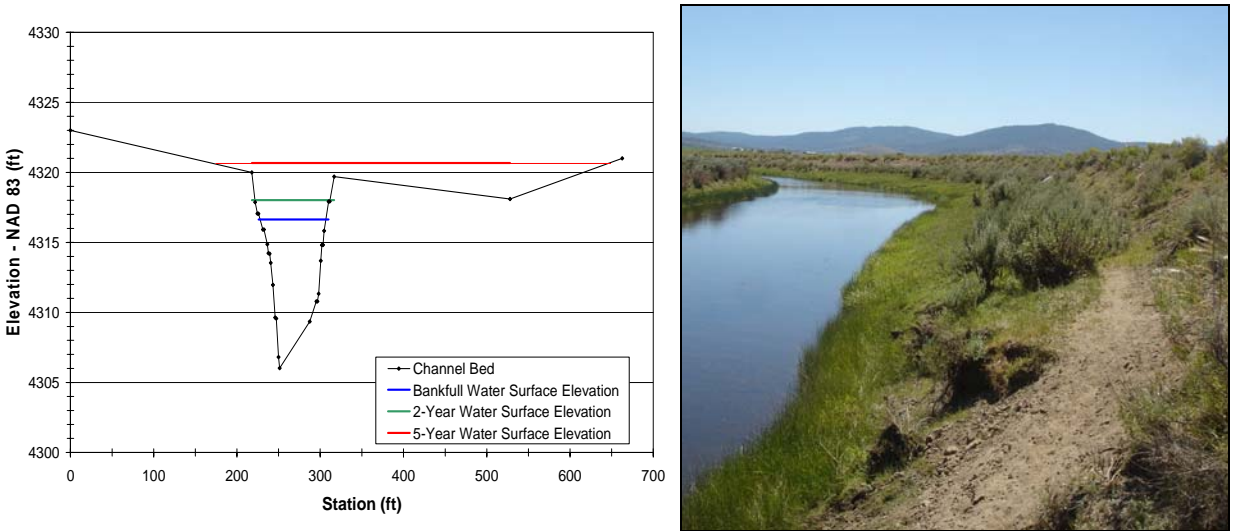
Figure E-12. The hydraulic channel cross-section at Station 6411 (left) and a ground photo taken upstream of the cross-section location illustrating typical river corridor conditions in lower Reach 5. The channel is confined between high terraces. Up to the 5-year event is contained in the channel. This area is also influenced by the backwater that is created when the Sprague River floods.

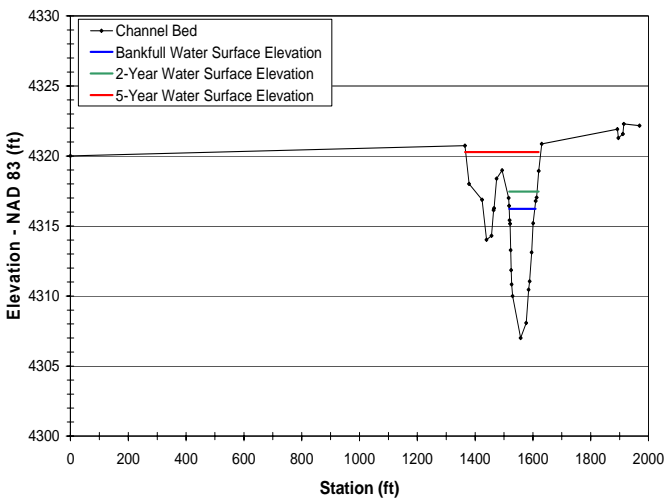
Figure E-13. The hydraulic channel cross-section at Station 2192 (left). The channel is confined between high terraces. A wetland adjacent to the channel provides off-channel habitat. The photo on the right shows the Sycan River during high water in May 2005. This area is also influenced by the backwater that is created when the Sprague River floods.

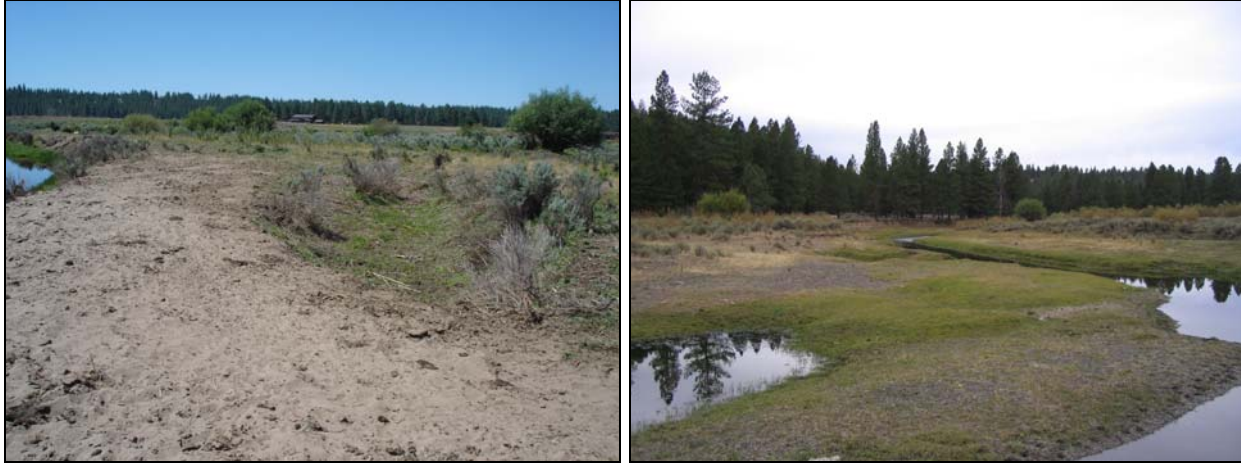
Figure G-1. Examples of grazing impacts on the Sycan River floodplain in the project area. Repeated trampling of floodplain areas (left) and grazing vegetation within the active channel corridor have led to channel instability.

surfaces decrease surface permeability and promote surface water routing. Disturbed surfaces are also more susceptible to noxious weed invasion. Cattle trampling of streambanks increases bank instability and erosion (Figure G-1). Repeated trampling related to travel routes breakdown banks and decrease vegetation diversity.

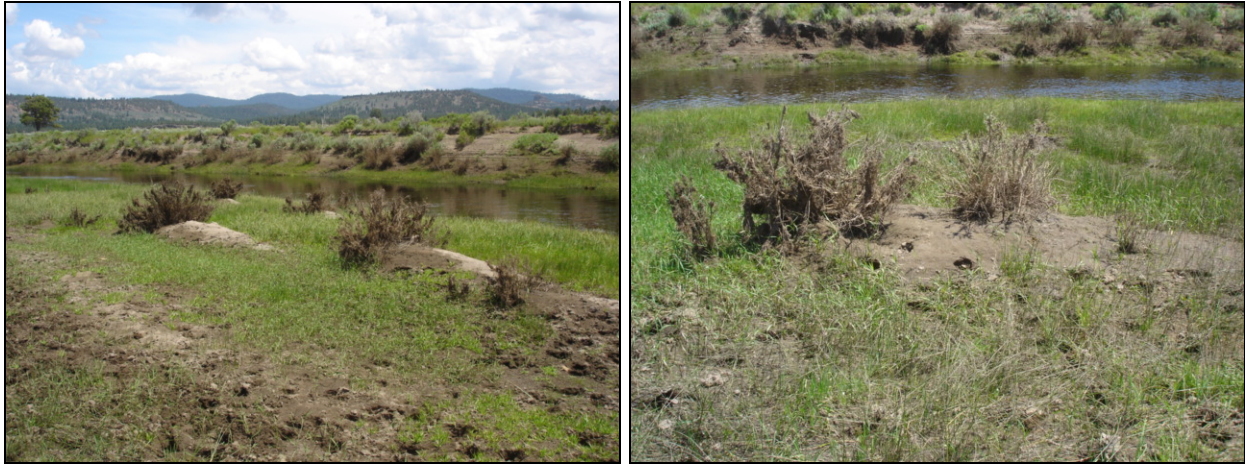
Figure G-2. Two examples of the influence of riparian vegetation on sediment trapping on the Sycan River illustrate the role of floodplain vegetation in storing fine sediment. Silver sagebrush on the floodplain creates turbulence and sediment deposition. If left undisturbed over time, these sites would be colonized by vegetation and bank building would take place.

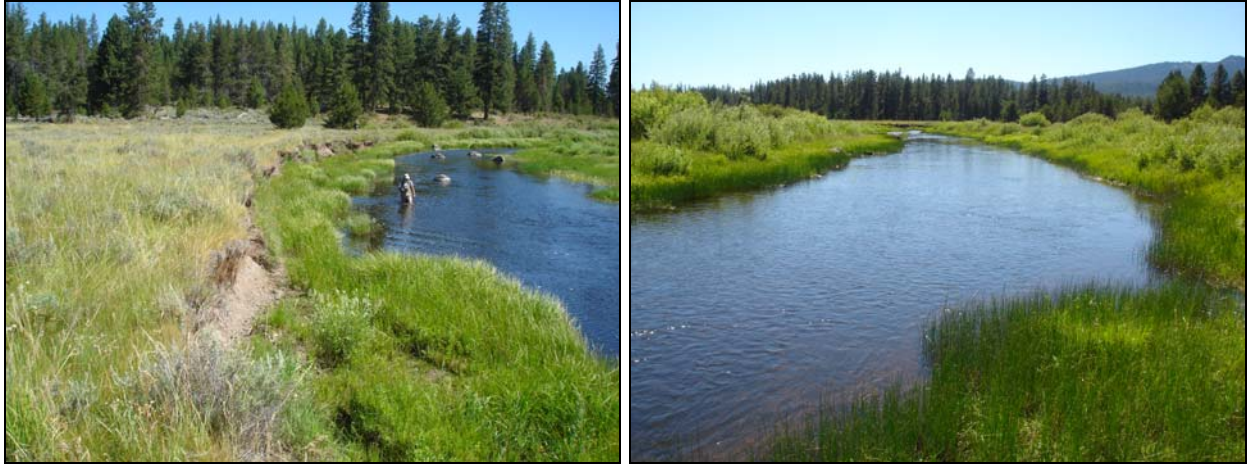
Figure G-3. Recovery riparian vegetation conditions in the Teddy Powers Meadows reference reach illustrate how vegetation responds to grazing exclusion. The vertical cutbank in the left photo is the old streambank prior to cattle exclusion. Complex riparian vegetation transitions from sedges/rushes at the water edge to willow thickets at slightly higher floodplain elevations. Vegetated fringes provide habitat for juvenile fish and amphibians.
