SYCAN RIVER ASSESSMENT AND RESTORATION FEASIBILITY STUDY

August 30, 2007

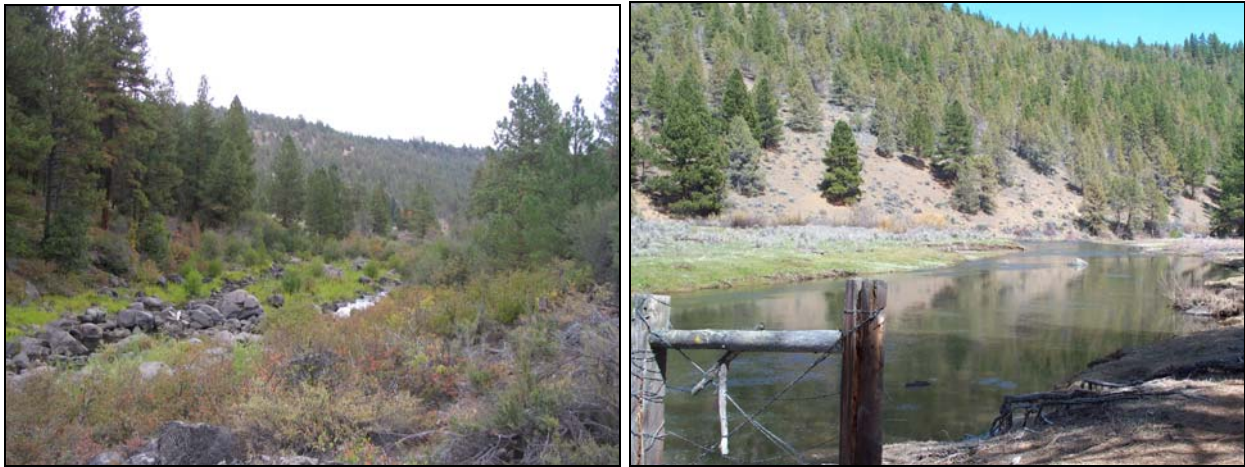
Figure G-4. The Coyote Bucket Canyon (left) and the transition to a wider valley and meandering channel (right). The canyon confines the Sycan River and there is no off-channel wetland development.

Very little wetland habitat exists in Reach 1 due to the confined nature of the channel leaving the Coyote Bucket Canyon. Downstream of the canyon mouth, the channel belt width expands as the valley widens (Figure G-4). There is little opportunity for wetland development in the canyon due to the confined valley bottom. Through Reach 1, the valley widens and the channel transitions from a steep confined channel, to a lower gradient meandering channel. The floodplain expands with the retreating valley walls and emergent palustrine wetlands are located to the west of the channel (Station 18+00 to 19+00). The wetland area conveys water during elevated flows and supports emergent vegetation and willows during the growing season. Inundated areas provide temporary shallow rearing habitats for fish and aquatic insects. At the mouth of the canyon, vegetation adjacent to the channel includes sedges/rushes and alder. Ponderosa pine and understory shrubs including snowberry occupy the transition to adjacent uplands. Riparian vegetation is more common and the upland plants recede through the transition to the broader floodplain.

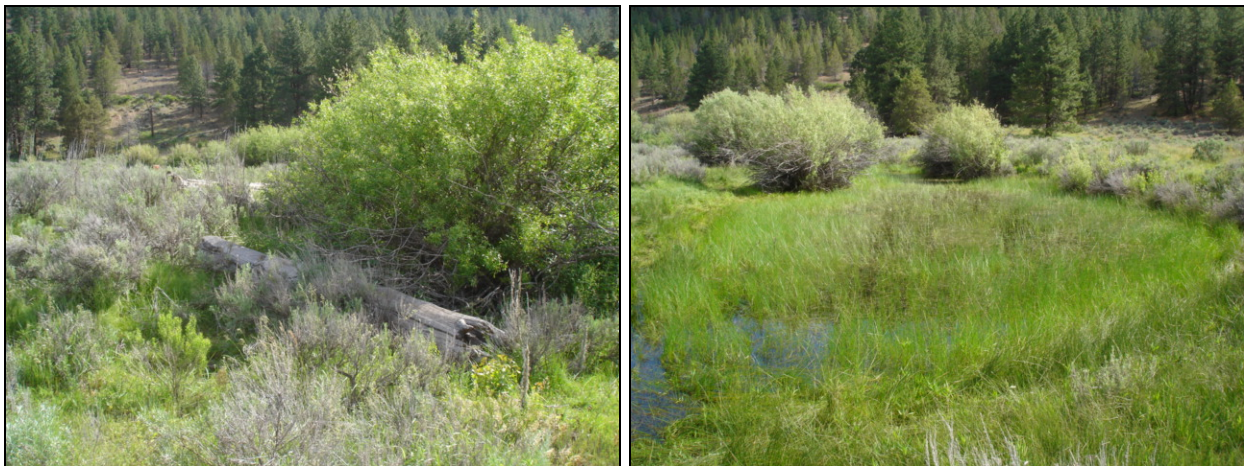
Figure G-6. Large wood is deposited on the Reach 2 floodplain (left). Swales on the terrace hold water through the spring and early summer (right).

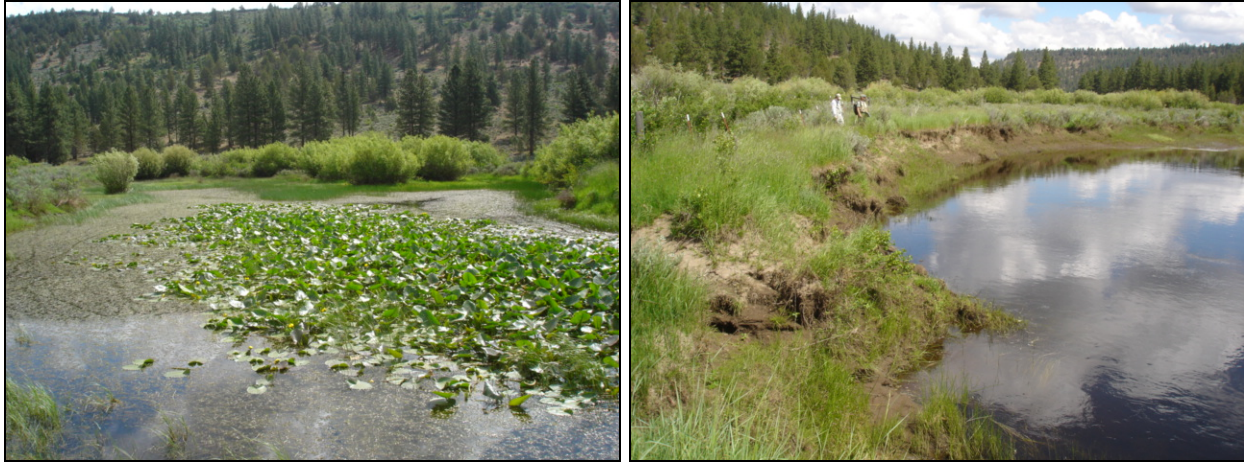
Figure G-7. A floodplain wetland in Reach 3 (left) occupies an historical channel location. Bank erosion in Reach 3 suggests the river is continuing to adjust to channel changes that have occurred over the past 60 years (right). Willow thickets in the background of the right photo show the location of relict channels.

Reach 3 extends from Station 76+00 to Station 137+00. The Sycan River valley bottom narrows as the eastern hillslope and the western terrace encroach on the channel. Wetland development in this section is limited to Station 90+00 through Station 102+00 (Figure G-7). West of the active channel is an historical channel meander that was last active in the 1941 air photos. The channel remains defined and contains water in the spring and early summer. The feature functions similarly to the wetlands in Reach 2. Large wood accumulations and riparian vegetation patterns are similar to the Reach 2 palustrine wetland.

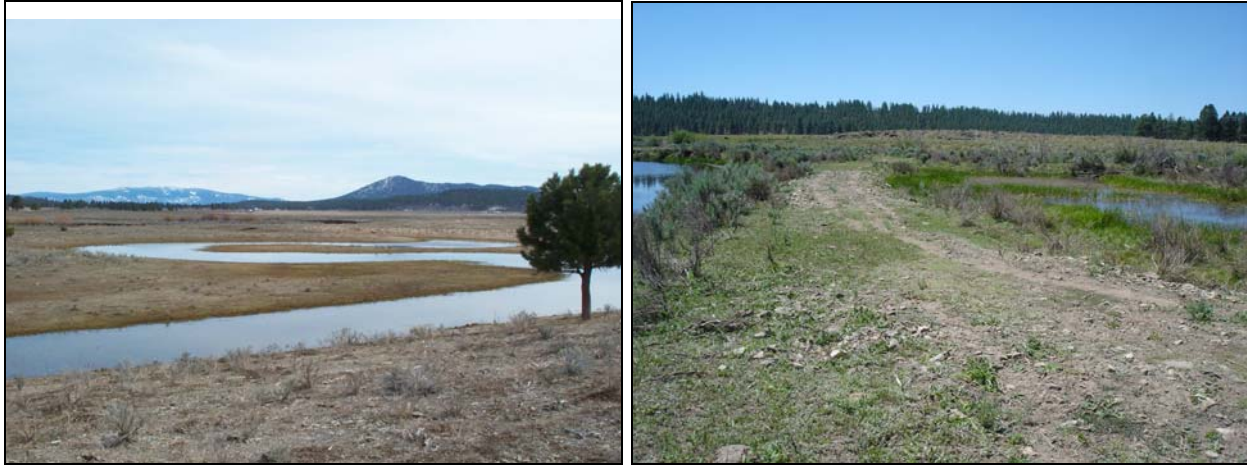
Figure G-8. A palustrine wetland on a terrace west of the Sycan River (left). An off-channel wetland adjacent to the Sycan River currently disconnected by floodplain fill (right).

Reach 5 extends from Station 172+00 to Station 363+00 at the Drews Road Bridge. Palustrine wetlands are associated with floodplain areas, the western terrace on the Kronenberger property, and at spring creek tributary confluence areas (Figure G-8). The floodplain areas are inundated during periodic flood events when the river leaves its low bank and access the valley bottom. The Kronenberger's palustrine wetlands located to the west of the Sycan River are inundated by groundwater during high flow periods, have springs that discharge into them, and are also augmented by groundwater wells.

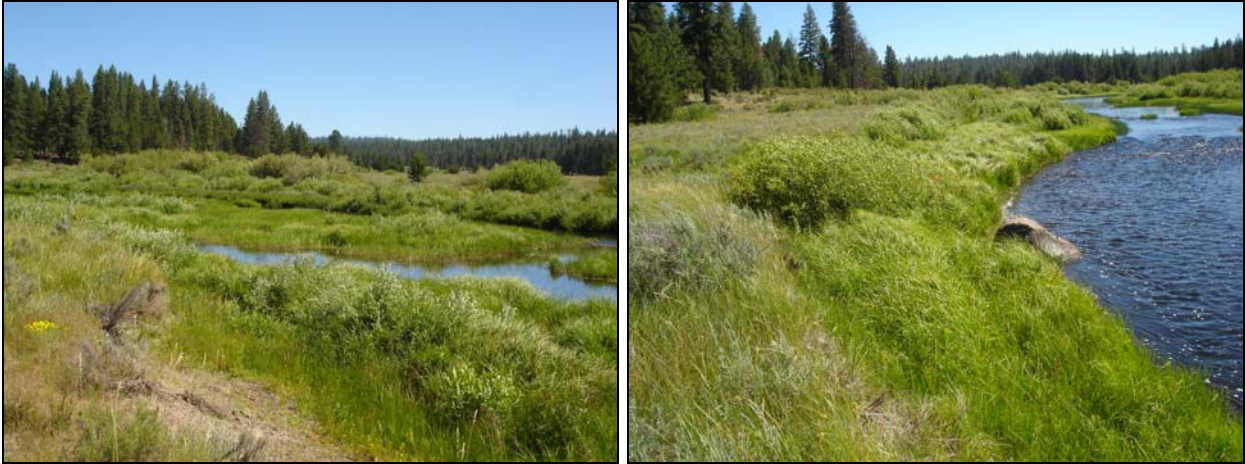
Figure I-1. Riparian vegetation in the Teddy Powers Meadows reference reach is characterized by sedges/rushes at the channel edge grading to willows at the edge of the active flood channel. Sage brush and other drier upland species occupy the low terrace.

The Teddy Powers Meadows section of the Sycan River was selected as a reference reach based on the riparian vegetation community, recovery of eroding stream banks, and the diverse channel morphology. The Teddy Powers Meadows section (reference reach) provides an example of the desired future condition for the project area (Figure I-1). The reference reach is characterized by a riparian vegetation community recovering from past season-long grazing. The reach exhibits a vegetation pattern that probably reflects a true early- to mid-seral reference condition for the majority of the Sycan River project area. The reference reach appears to be fifteen to twenty years into a period of recovery from season-long grazing, a land use pattern that is still occurring in much of the project area. Vegetation in the reference reach consists of a narrow fringe of perennially inundated rush/sedge communities along the channel margin transitioning to seasonally inundated sedge/rush and willow communities. Above the sedge/rush and willow communities is a floodplain terrace dominated by big sagebrush.

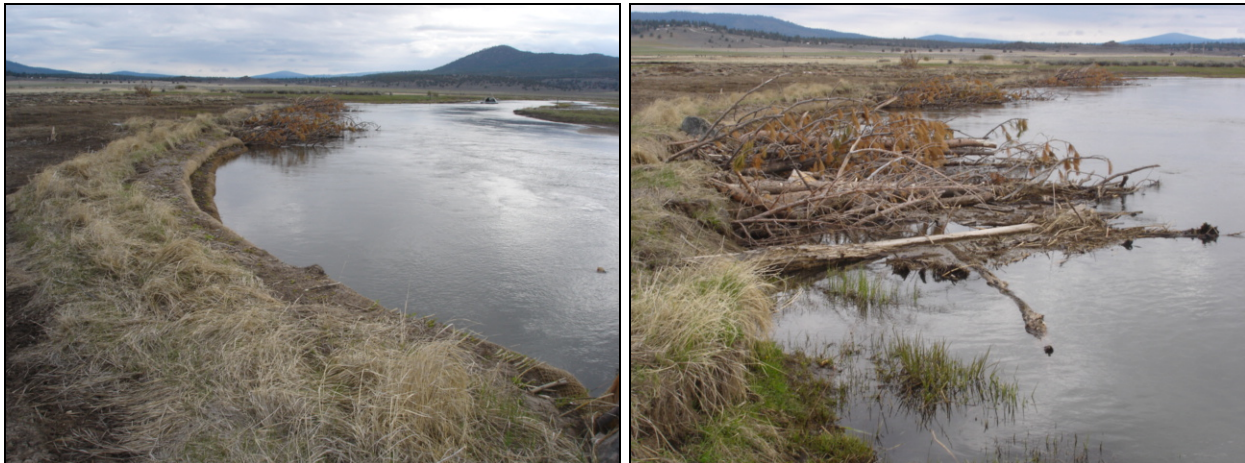
Figure I-6. Example bioengineering (left) and engineered log jams (right) on the Sprague River. Bioengineering and log jams provide bank stability and diverse aquatic habitat. Over time, the willows planted in the soil lift will form a dense willow thicket.

Potential bioengineering treatments would be directed towards enhancing habitat, promoting sediment deposition, and accelerating revegetation. Example projects would include stable large wood placement in the active channel and off-channel wetlands. Planting willow cuttings would be an additional treatment to potential speed willow colonization in areas where they have been displaced by grazing. Figure I-6 illustrates engineered log jams and bioengineering projects completed on the Sprague River.

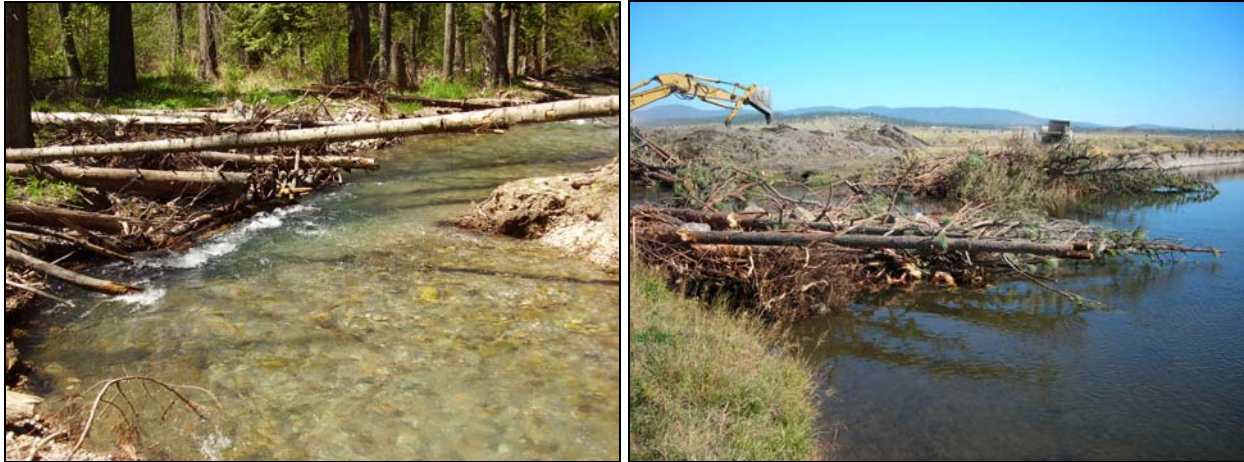
Figure I-7. Example ELJs constructed on a moderate gradient alluvial stream in Idaho (left) and on the Sprague River near Beatty, Oregon (right).

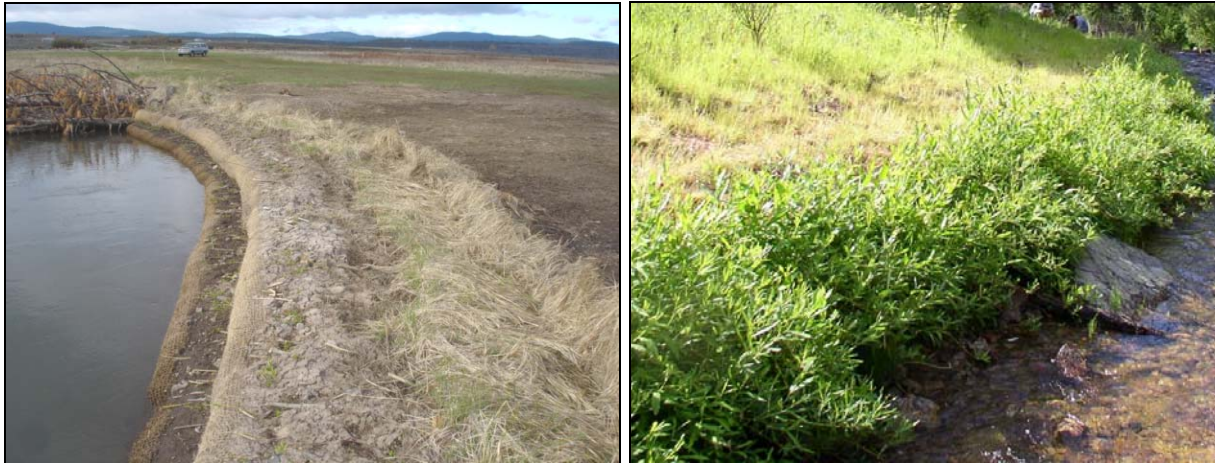
Figure I-8. Examples of soil lifts on the Sprague River (left) and Belmont Creek (right). The Sprague River photo was taken in the spring following installation. The Belmont Creek photo was taken 2 years after installation.

Vegetated soil lifts are a revegetation and bank construction technique that combines layers of dormant willow cuttings with fabric-wrapped soil to revegetate and stabilize stream banks and slopes. Soil is wrapped within two layers of biodegradable coconut fiber (coir) fabric, to hold the soil in place while vegetation becomes established in the relatively high stress land/water interface. Soil lifts, combined with a bankfull bench, will result in near bank areas where native woody vegetation can become established. To increase success, the face of soil lifts should be reinforced with either a coir log or coir wattle to help maintain the lift shape, keep fine soil particles from filtering out through the lift face, and maintain surface tension. In addition to these functions, coir wattles also retain moisture. If a combination of the two is desired, coir logs should be used in areas where greater strength and moisture capacity are needed. Note that coir wattles are a lower density version of coir log fascines, described below. The uppermost soil lift should be filled with salvaged sod or seeded with the seed mix developed for the site. Example soil lifts are included in Figure I-8.
